CONSERVATION RESOURCE ALLIANCE

Little Manistee River Eroding Stream Bank Assessment

Carrieville (Kings Highway) Bridge to Old Stronach Rd. Bridge

12/31/2014

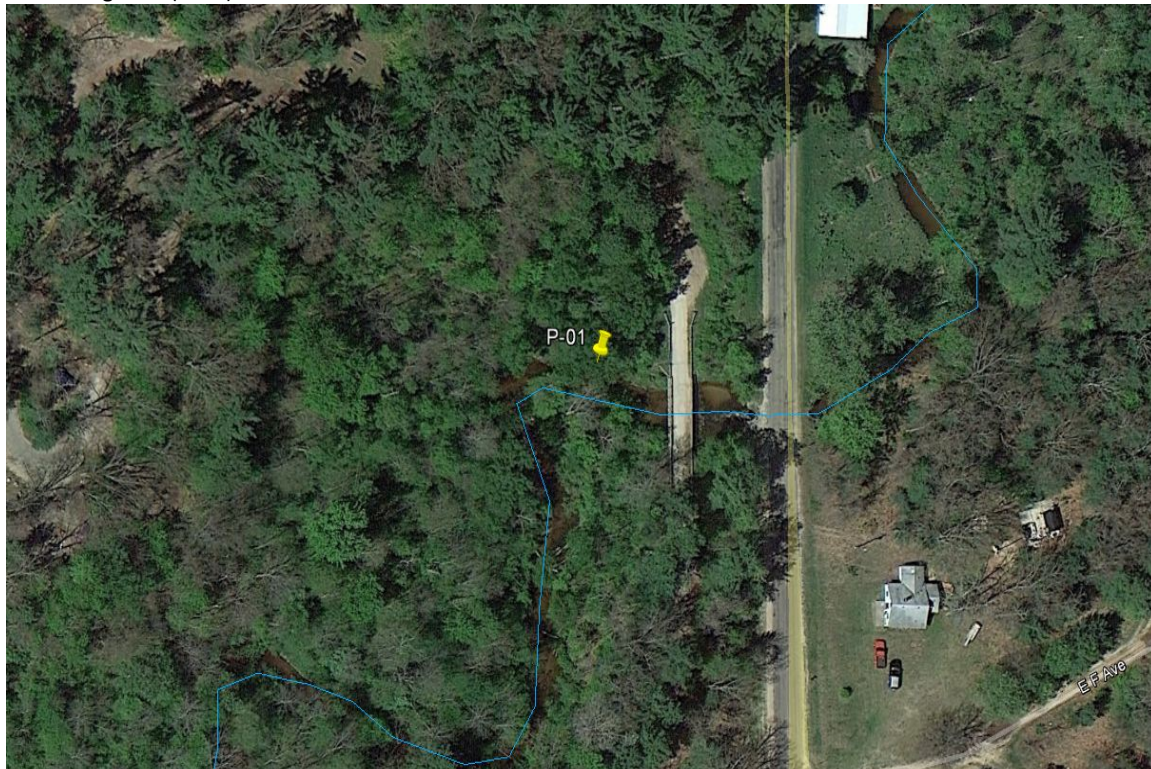
Site 1

Aspect: S

Slope: Vertical

Length: 30'

Height: 4'

Severity: Minor

Notes: water depth 2.5-3.0' maximum, substrate sand, some gravel and wood

View straight on (2013)

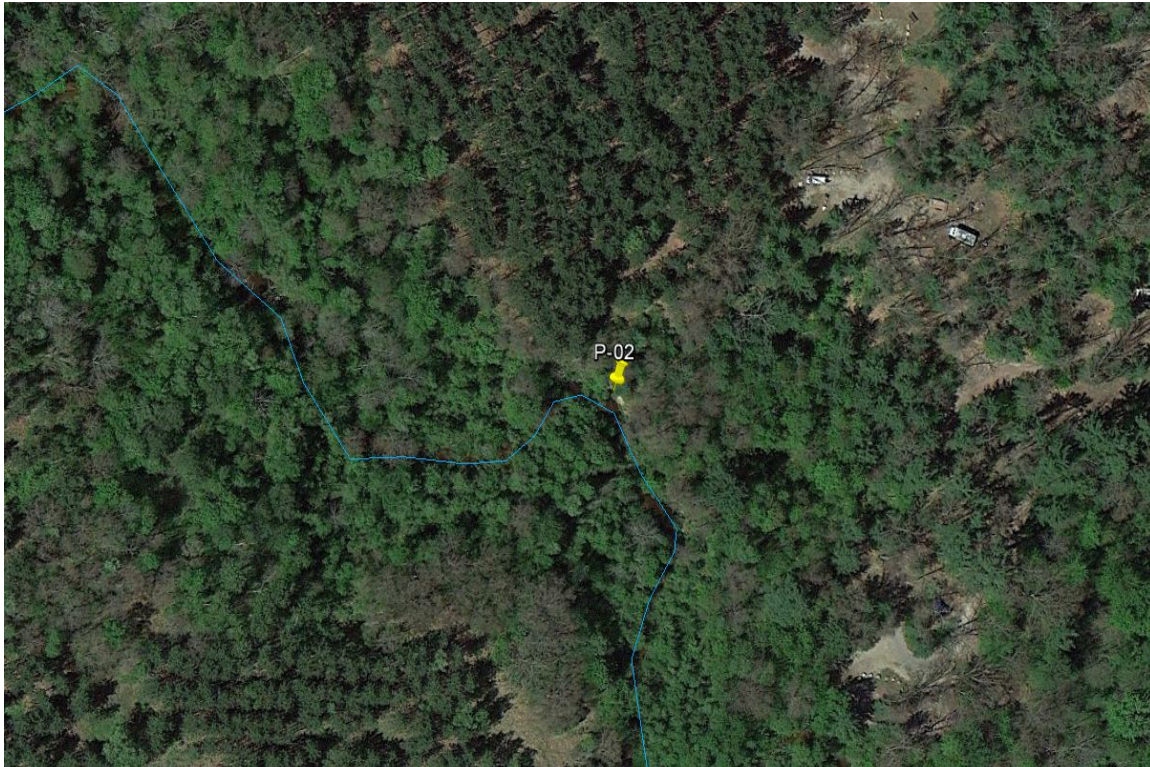
Site 2

Aspect: SW

Slope: 1:1

Length: 12'

Height: 7'

Severity: Moderate

Notes: substrate sand, channel width 16', water depth 2.0-4.0' maximum

View straight on (2013)

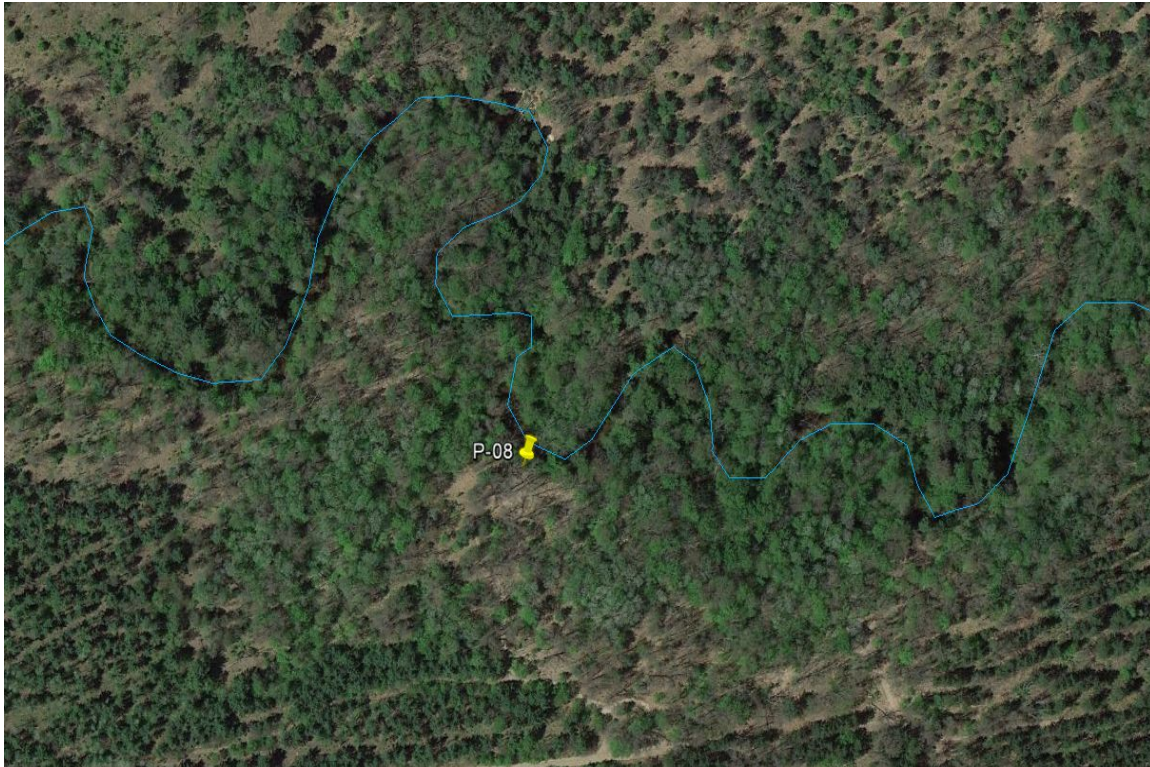
Site 8

Aspect: SE

Slope: 1:1

Length: 20'

Height: 12-15'

Severity: Minor

Notes: channel width 24', water depth .5', substrate sand

View downstream (2013)

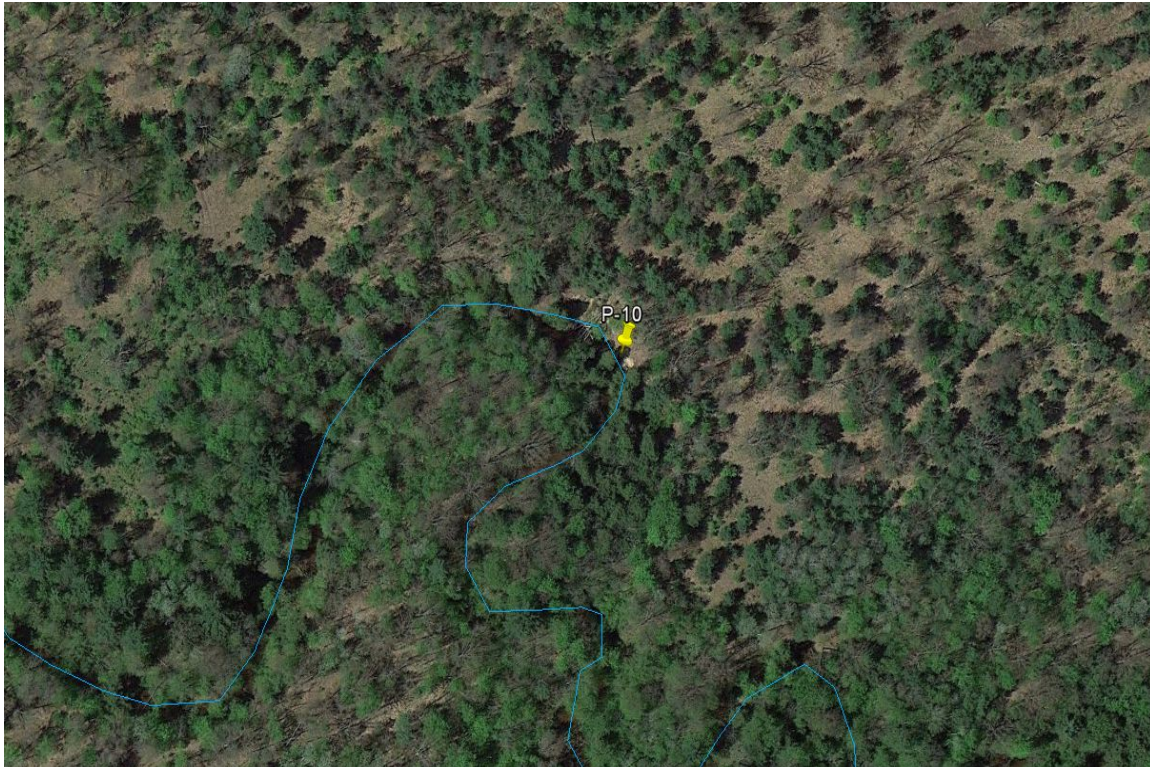
Site 10

Aspect: W

Slope: Vertical

Length: 50'

Height: 20'

Severity: Severe

Notes: water depth 4"-2.5', channel width 20', substrate sand

View downstream (2013)

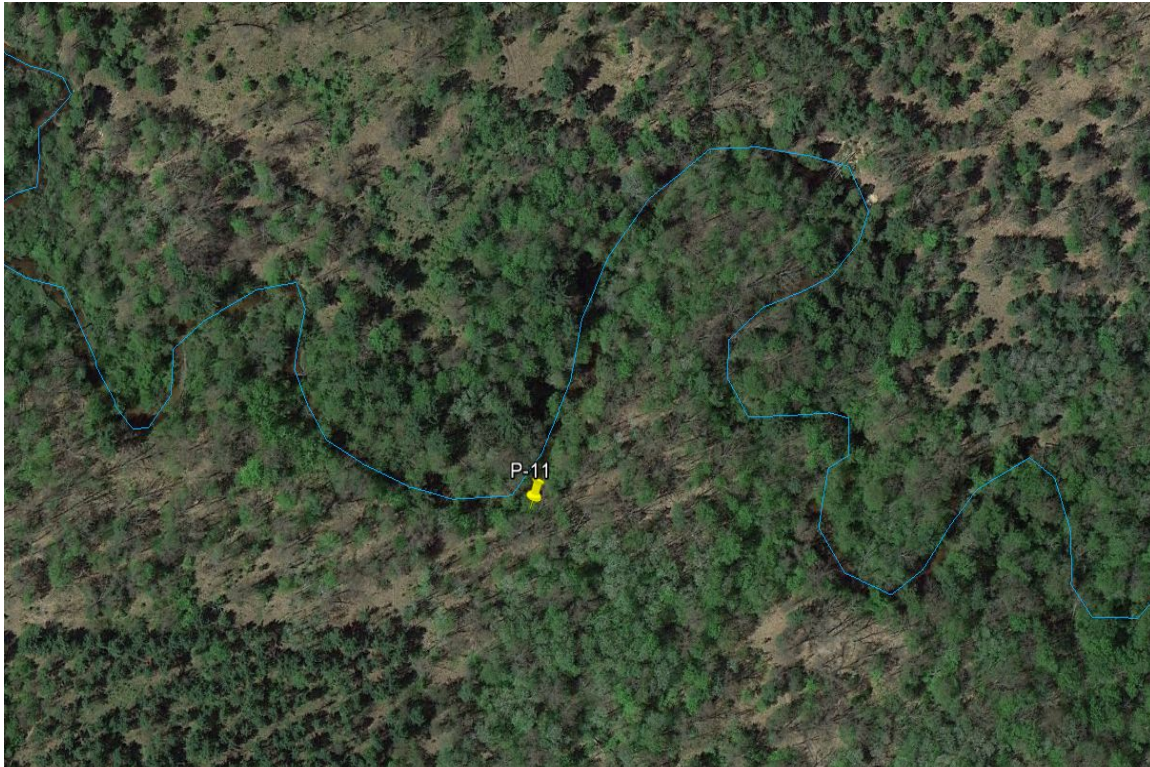
Site 11

Aspect: ESE

Slope: 1:1

Length: 20'

Height: 15'

Severity: Minor

Notes: water depth 1'-2.0', substrate sand/some gravel, channel width 24'

View straight on (2013)

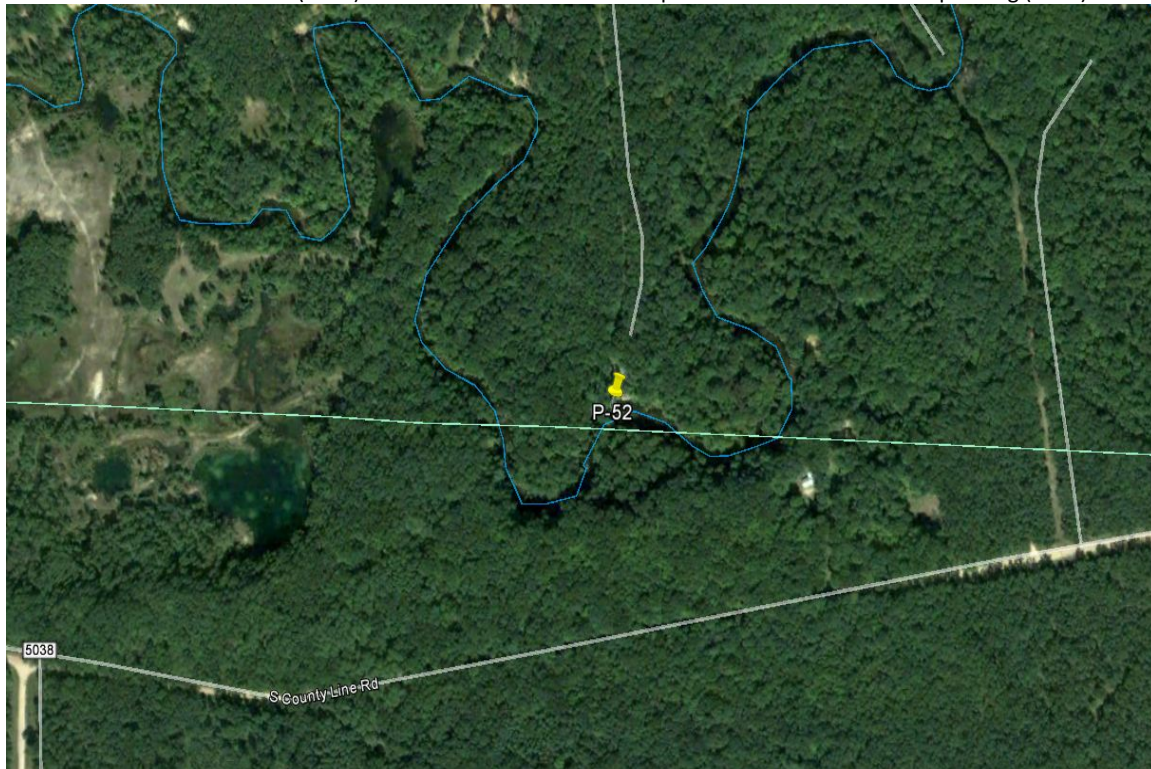
Site 52

View upstream and across-note maple snag (2014)

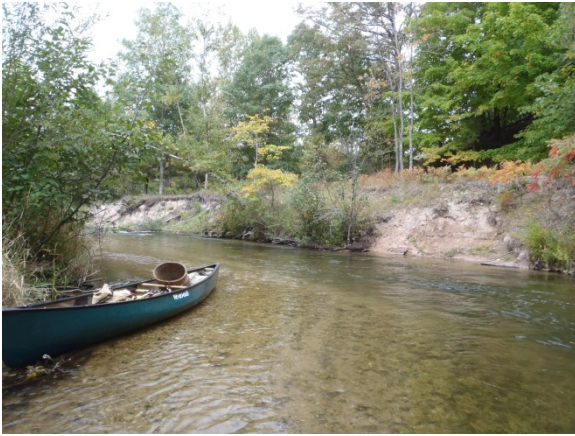
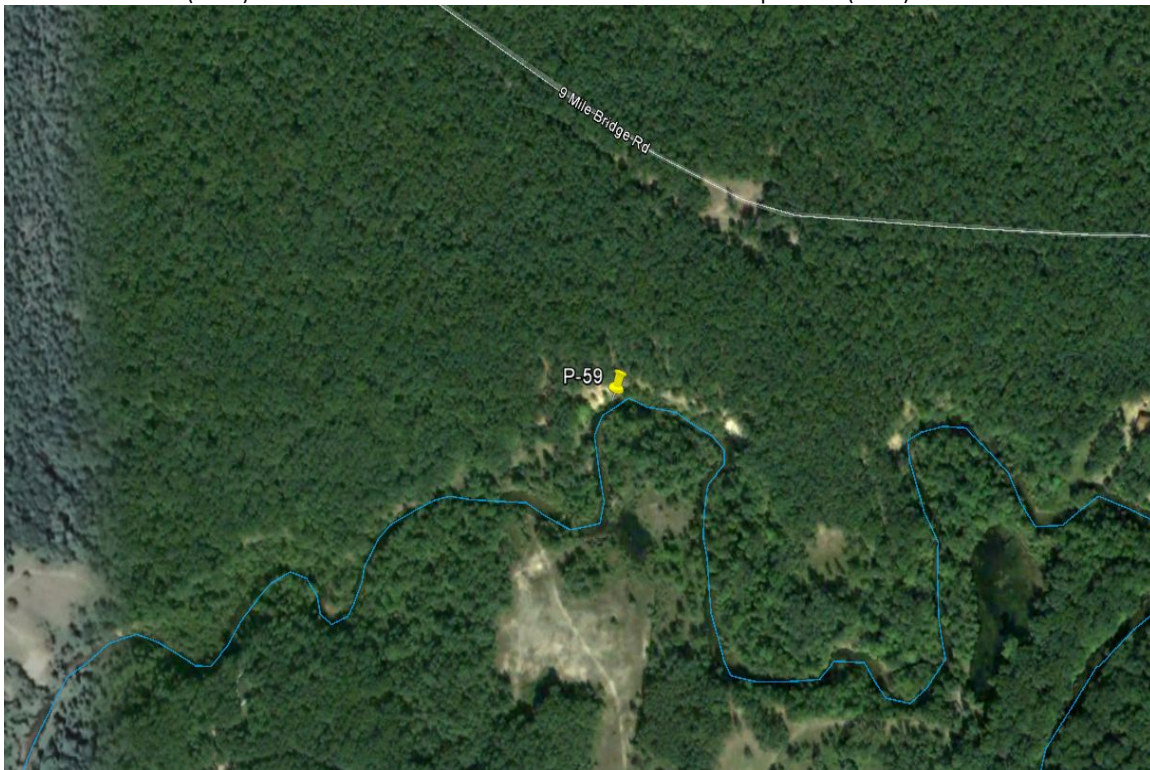
Site 59

Notes: angler access, continuation of prior site, clay exposed in bank, back eddies caused by debris jam, depth at toe 3'

View downstream (2011)

View across and upstream (2014)
