CONSERVATION RESOURCE ALLIANCE

Little Manistee River Eroding Stream Bank Assessment

Carrieville (Kings Highway) Bridge to Old Stronach Rd. Bridge

12/31/2014

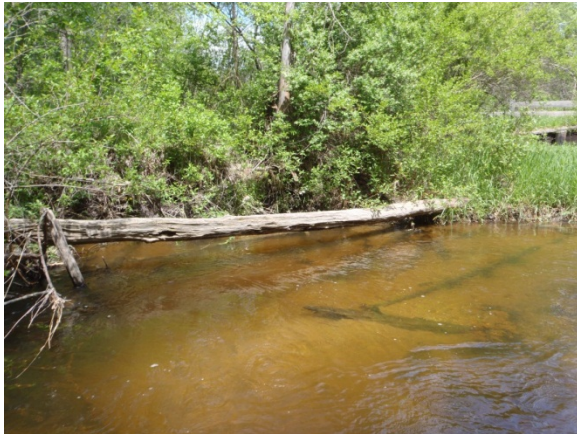
River-right

Notes: water depth 2.5-3.0' maximum, substrate sand, some gravel and wood

View straight on (2013)

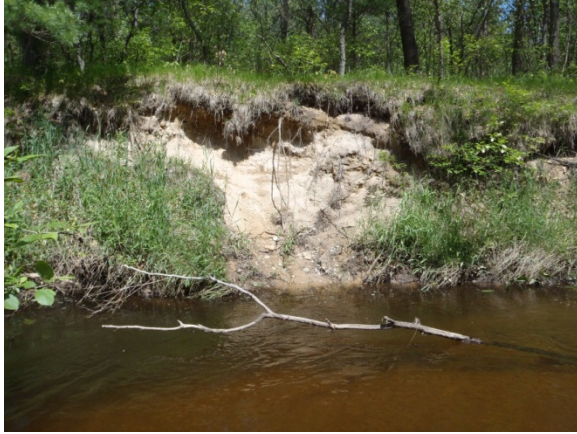
River-right

Notes: substrate sand, channel width 16', water depth 2.0-4.0' maximum

View straight on (2013)

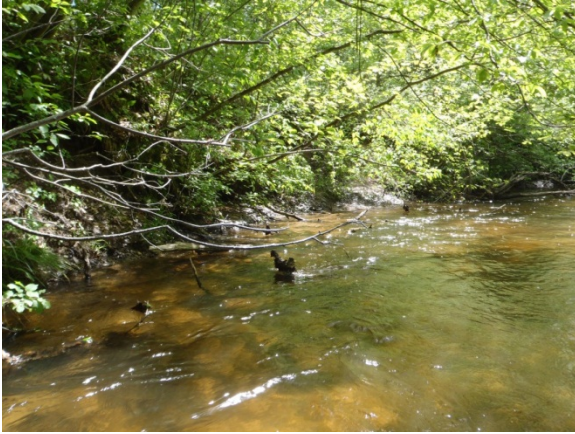
River-left

Notes: channel width 20', substrate sand, water depth 2.5-3.0' maximum

View downstream (2013)

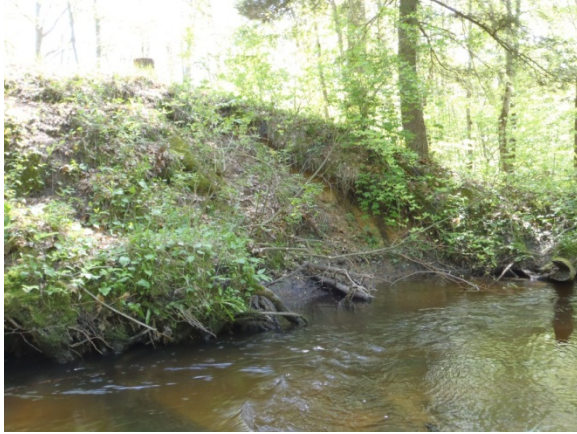
Site 4

River-left

Notes: water depth 3.0', channel width 12', substrate sand

View downstream (2013)

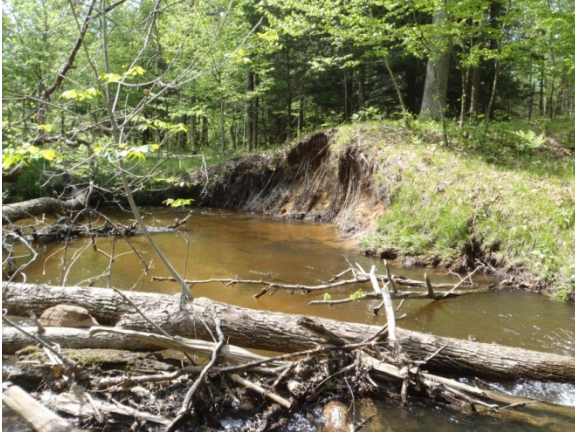
Site 5

River-right

Notes: water depth 1'-2.5', substrate sand/some gravel

View downstream and across (2013)

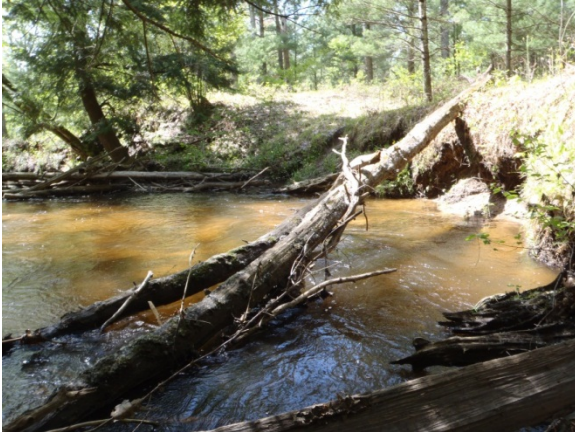
Site 6

River-right

Notes: substrate gravel/some sand, channel width, water depth .5'-1.5'

View downstream (2013)

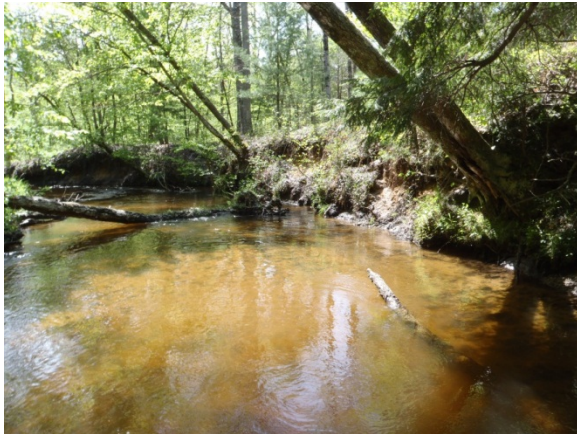
Site 7

River-right

Notes: substrate sand/some gravel, water depth 1'-2', channel width 15'

View downstream (2013)

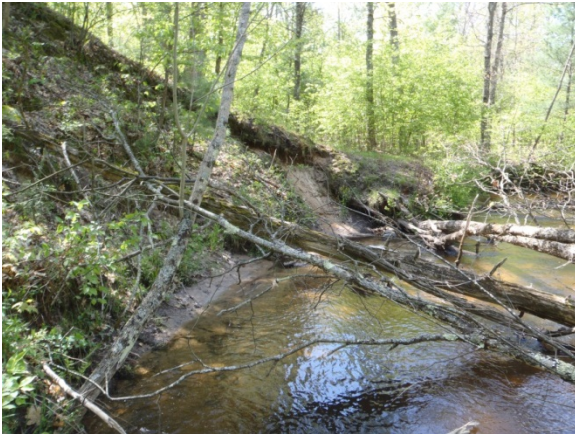
Site 8

River-left

Notes: channel width 24', water depth .5', substrate sand

View downstream (2013)

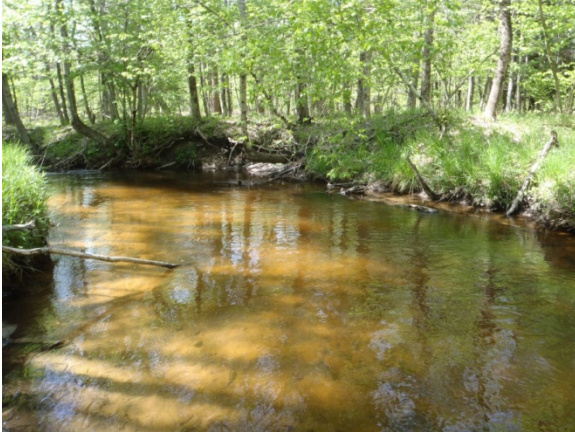
River-right

Notes: channel width 20', water depth 1'-2.5', substrate sand/some gravel

View downstream (2013)

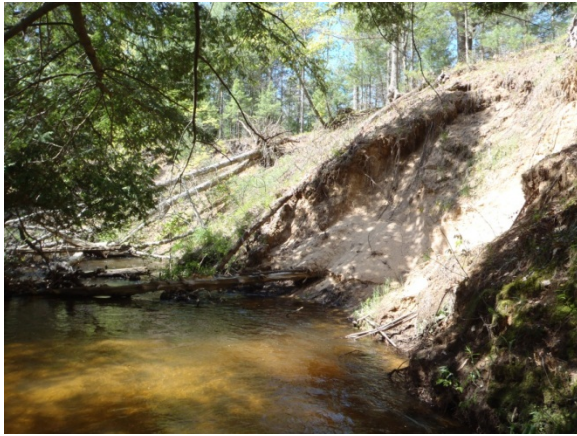
Site 10

River-right

Notes: water depth 4"-2.5', channel width 20', substrate sand

View downstream (2013)

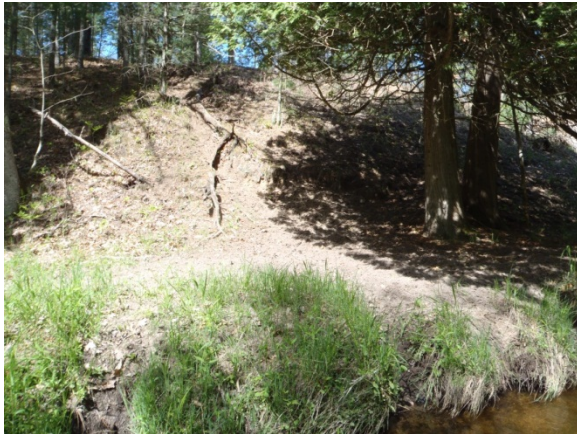
River-left

Notes: water depth 1'-2.0', substrate sand/some gravel, channel width 24'

View straight on (2013)

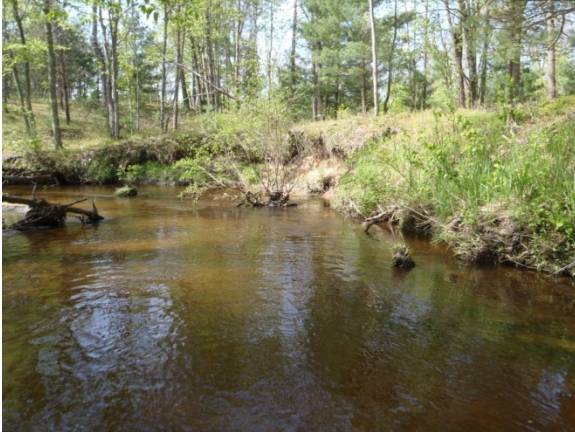
River-right

Notes: water depth 1'-1.5', substrate sand/some gravel, channel width 24'

View downstream (2013)

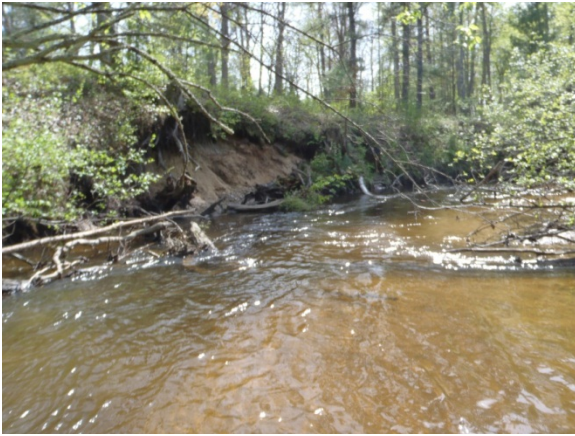
Site 13

River-left

Notes: channel width 15', substrate sand, water depth .5'-3.0'

View downstream (2013)

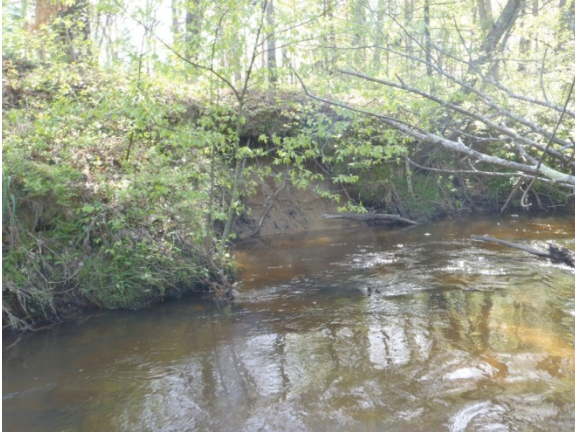
Site 14

River-left

Notes: water depth .5'-2.0', substrate sand, channel width 30'

View downstream (2013)

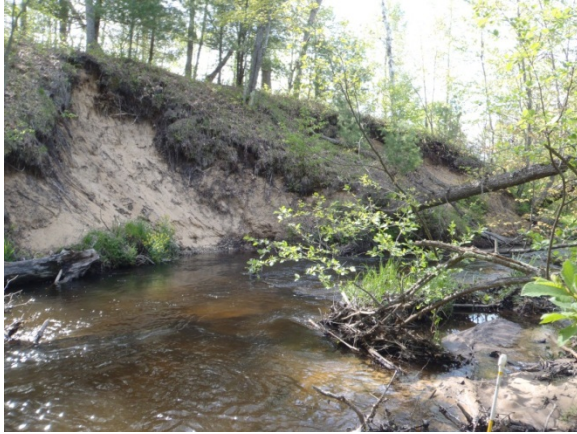
Site 16

River-right

Notes: channel width 30', water depth .5'-2.0', substrate fieldstone/sand

View upstream (2013)

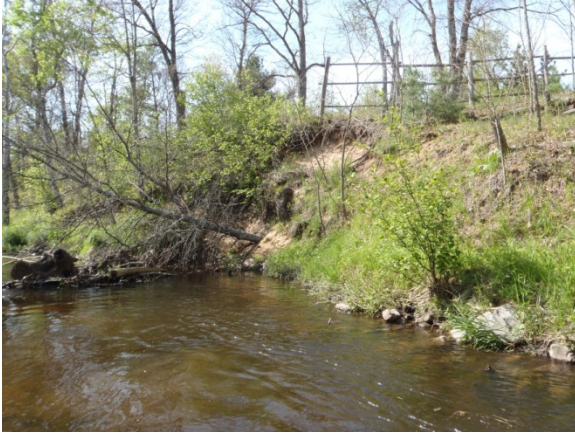
Site 17

River-right

Notes: water depth 2.0'-3.0', substrate sand, channel width 20'

View downstream (2013)

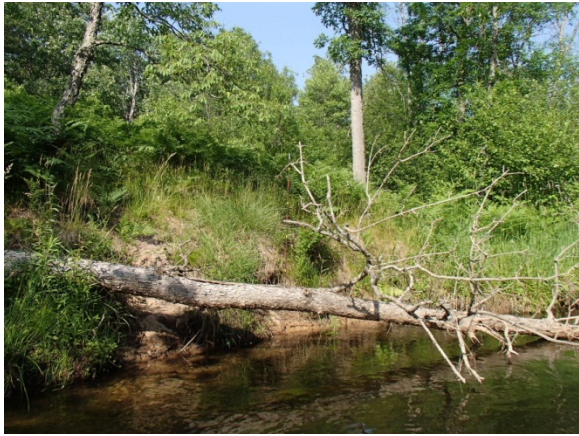
River-right

Notes: channel width 24', water depth 3.0', substrate sand

View straight on (2013)

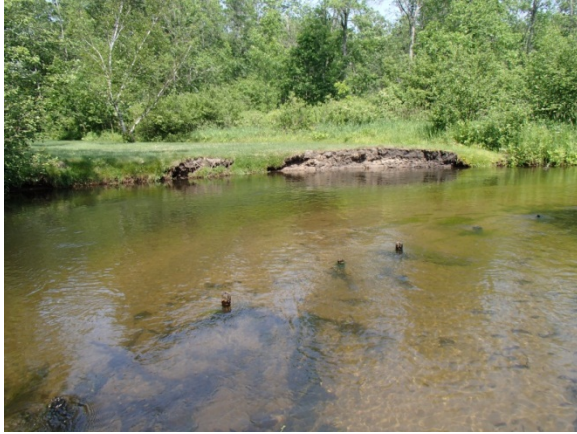
Site 19

River-right

Notes: water depth 4.0'-4.5', substrate sand/some gravel, channel width 43'

View upstream and across (2013)

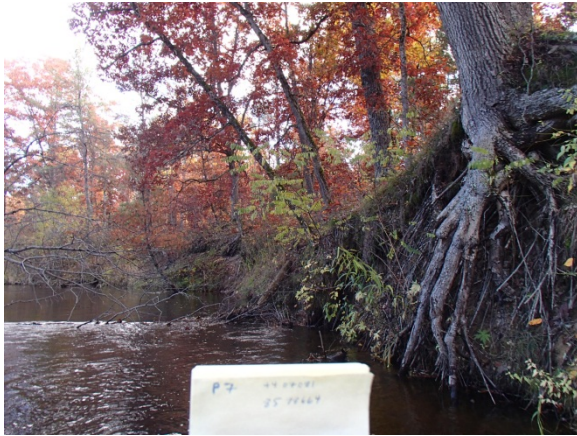
Site 21

River-left

Notes: depth at toe 3'

View upstream (2014)

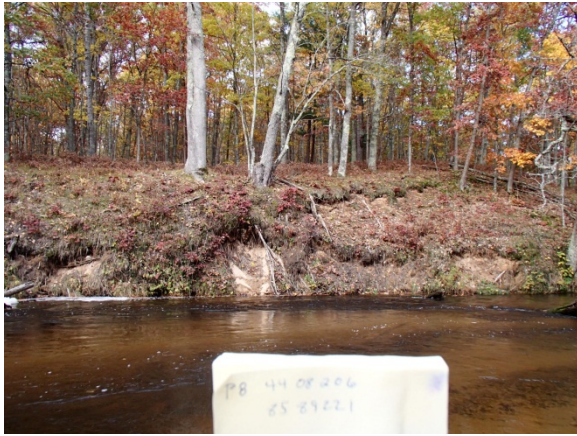
River-right

View straight across (2014)

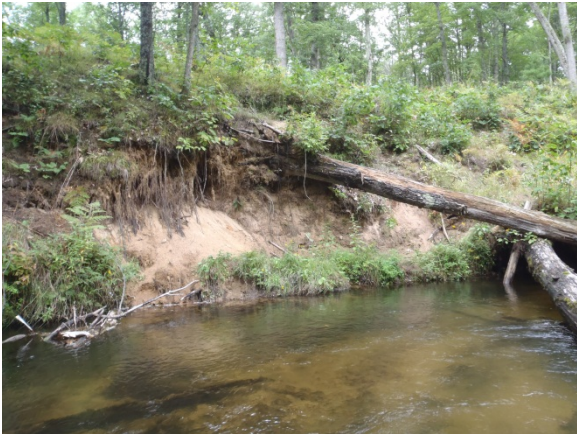
Site 24

River-right

View straight on (2011)

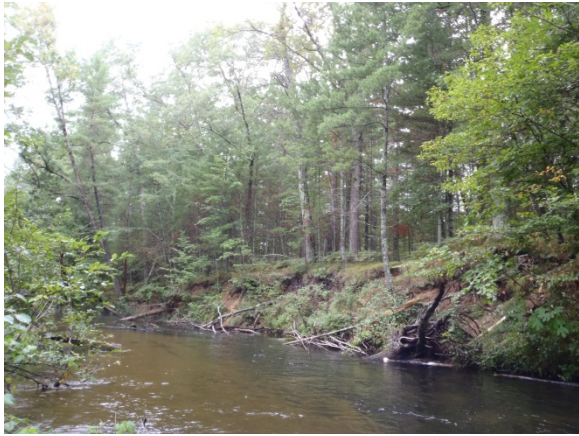
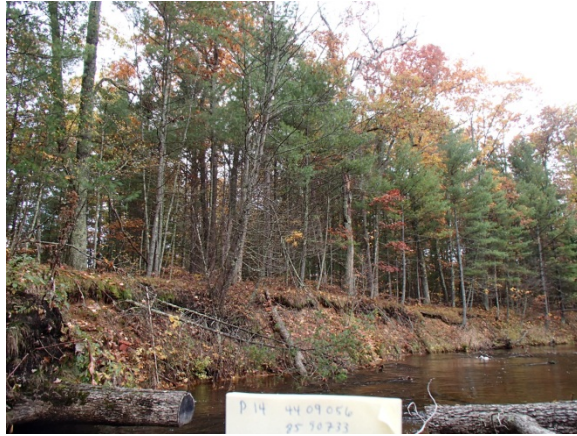
River-right

Notes: some clay expressed at toe, water depth 3', (toe is well buffered from current, re-vegetation occurring)

View downstream (2011)

View upstream (2014)

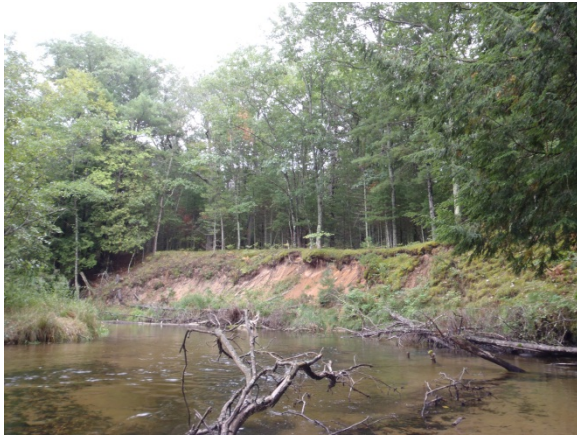
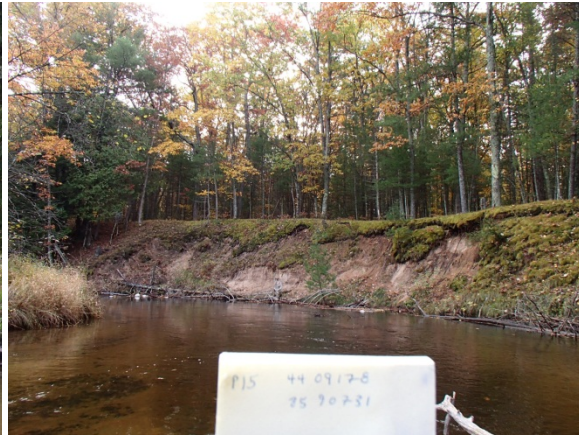
Site 26

Severity: Minor (toe is well buffered from current, re-vegetation occurring)

River-right

Notes: has had work done prior at the toe

View downstream (2011)

View downstream (2014)

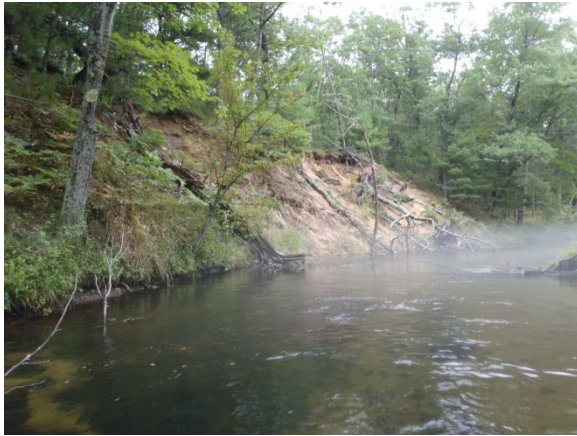
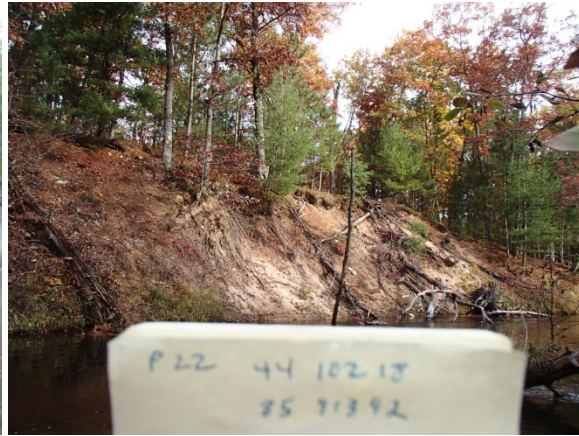
Site 27

Severity: Severe

River-left

Notes: outside of meander bend, low effort fix would be to secure large wood at toe to buffer flow

View downstream (2011)

View downstream (2014)

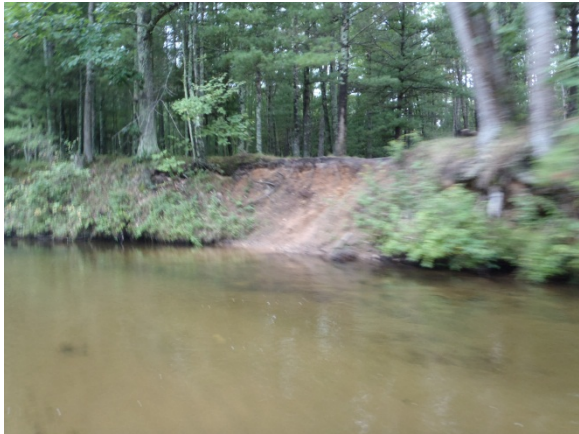
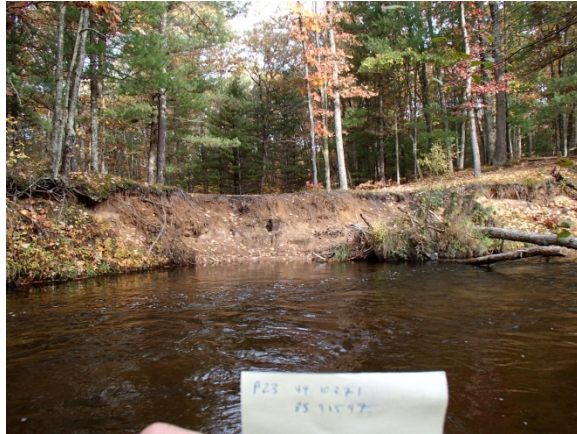
Site 28

Slope: 1:1 (from 2:1 in 2011)

Severity: Severe

River-right

Notes: the site trended from moderate to severe between 2011 and 2014 indicating recreational access may be one of the major influences to pursue on many sites

View from slightly upstream (2011)

View from slightly downstream (2014)

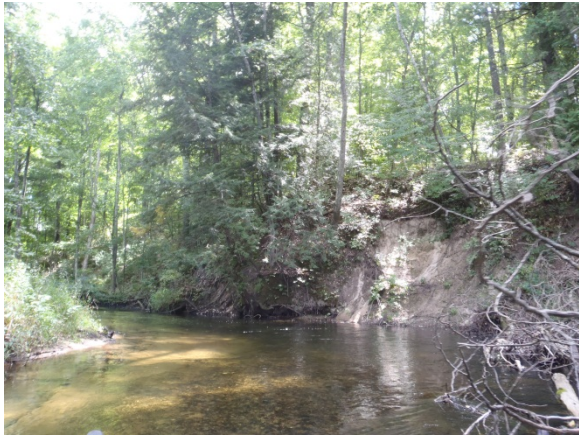
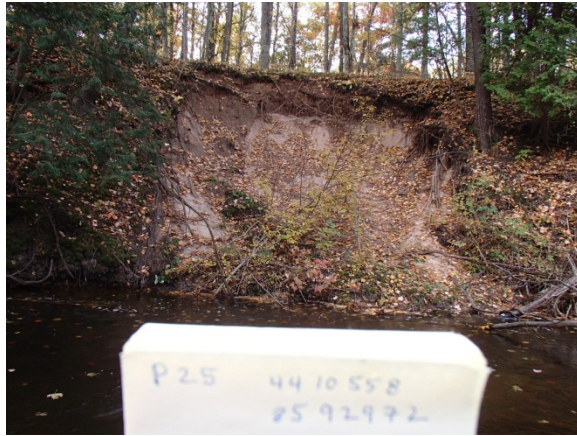
Site 29

Severity: Severe

River-left

Notes: note 2014 photo top of bluff has slumped to water level and is protecting toe, depth at toe 3.5'

View from downstream (2011)

View directly across (2014)

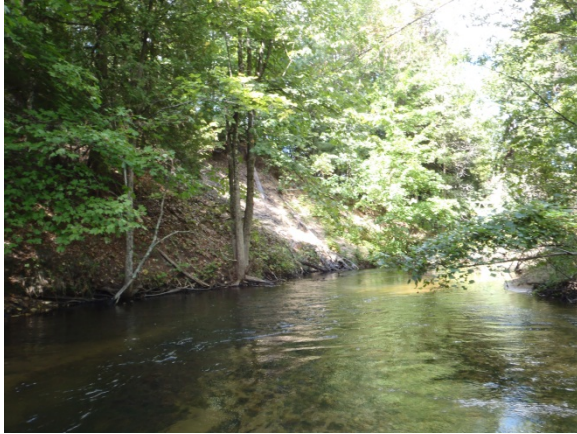
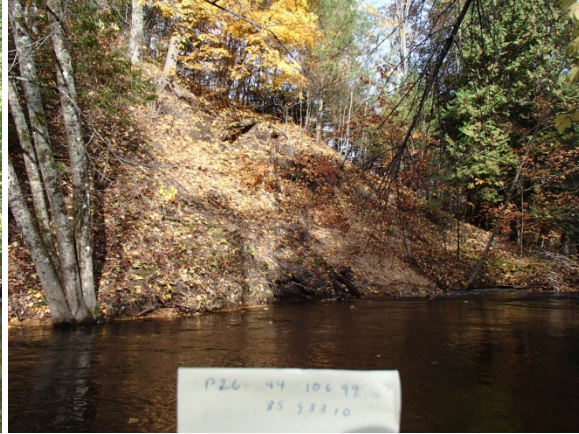
Site 30

Severity: Severe

River-left

Notes: active bleeding of sediment into stream, obscured by leaf drop in 2014 photo, depth at toe 3.5'

View from upstream (2011)

View straight across (2014)

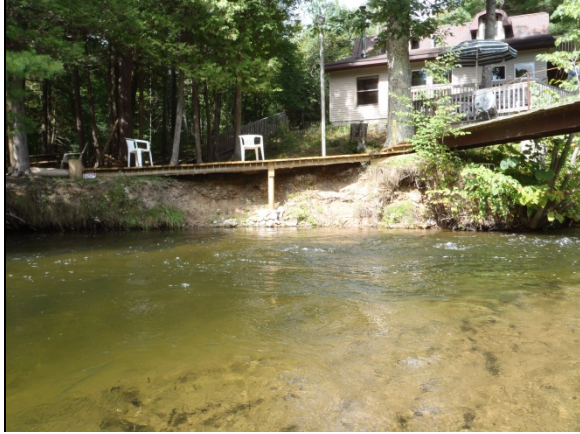
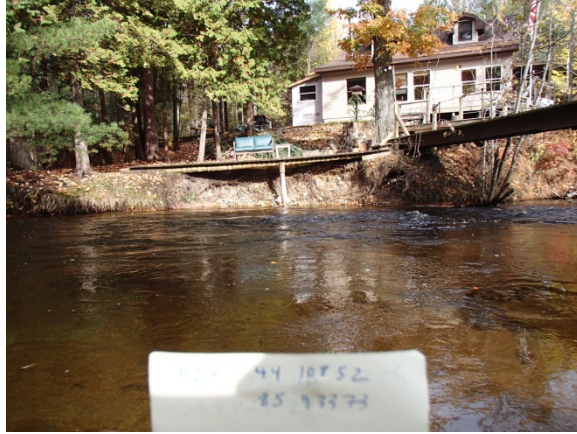
Site 31

Severity: Moderate

River-right

Notes: high clay content in bank material, low rate of sloughing, depth at toe 6'

View straight across (2011)

View straight across (2014)

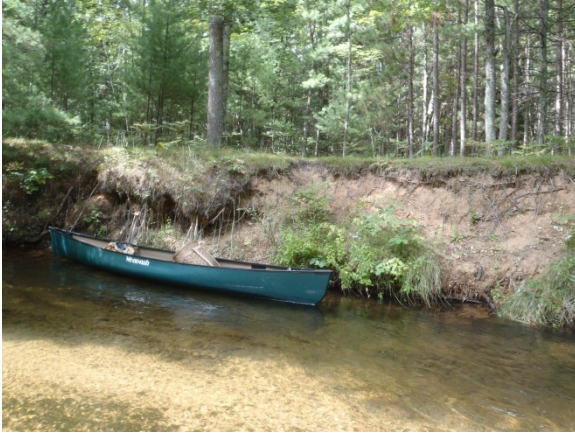
Site 32

Severity: Moderate

River-left

Notes: channel width 43', substrate gravel/sand, depth at toe 2'

View upstream and across (2011)

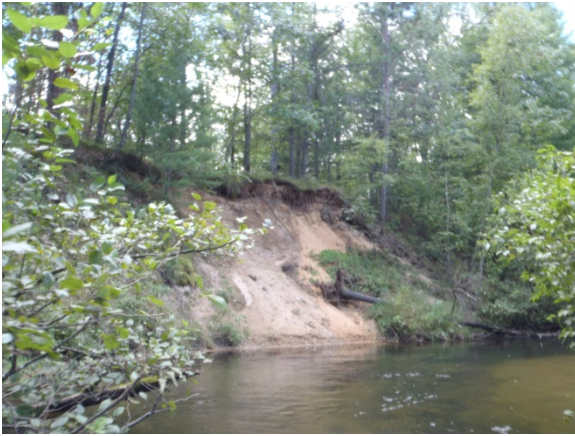
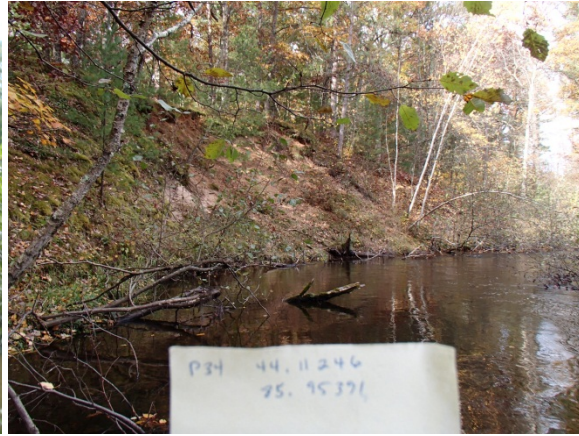
Site 33

Severity: Severe

River-left

Notes: outside of meander bend, channel width at this location 28', water depth 4', substrate fine sediment/gravel/sand

View looking downstream (2011)

View looking downstream (2014) (note toe stabilized)

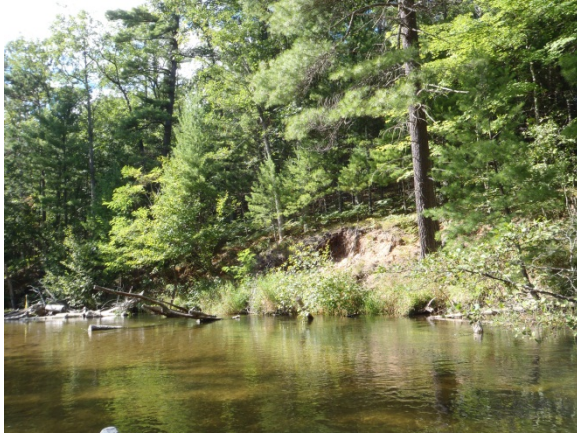
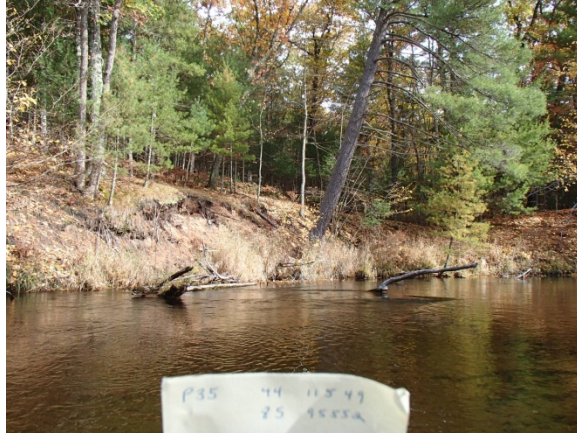
Site 34

Severity: Minor (no flow access to toe, re-vegetating on its own)

River-right

Notes: channel width 30', substrate fine sediment/sand/large wood

View downstream (2011)

View upstream (2014)

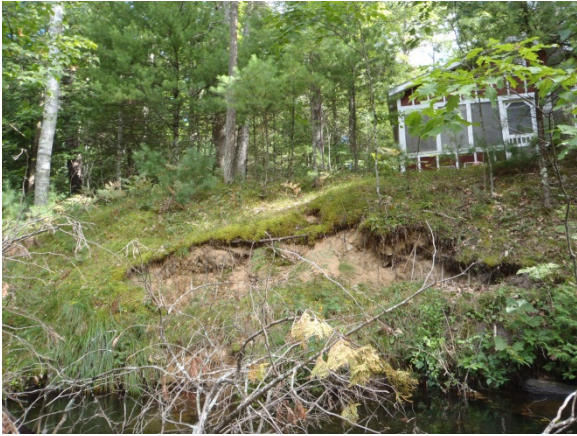
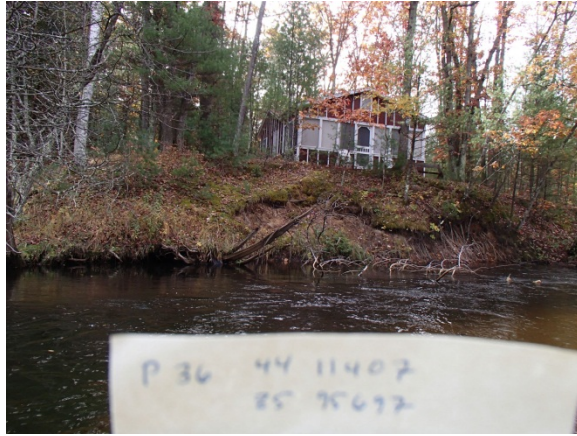
Site 35

Severity: Moderate (though trending to severe)

River-left

Notes: river width 30-32', water depth at toe 4.5-5', substrate small gravel, sand, large wood, current slow

View at toe (2011)

View from across (2014)

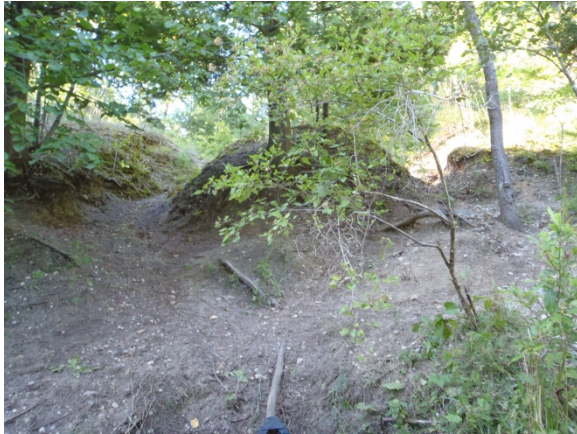
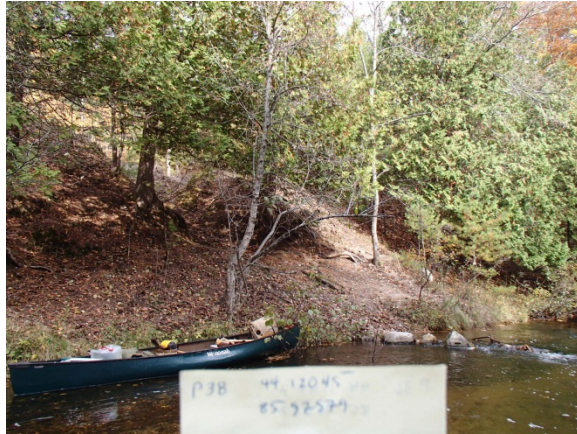
Site 36

River-right

Notes: channel width 46', water depth 1.5', two-track at top of bluff, recreational foot traffic, trail on both sides of river, substrate small gravel/sand/organic material/macrophytes (primarily *naiad*)

View looking straight on (2011)

View looking upstream and across (2014)

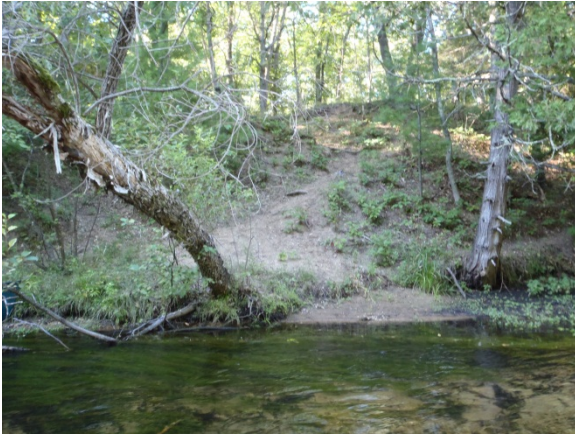
Site 37

River-right

Notes: two-track at top of bluff, recreation foot traffic, trail on both sides of river, channel width 46', substrate small gravel/sand/organic material/macrophytes, depth at toe 1.5'

View straight on (2011)

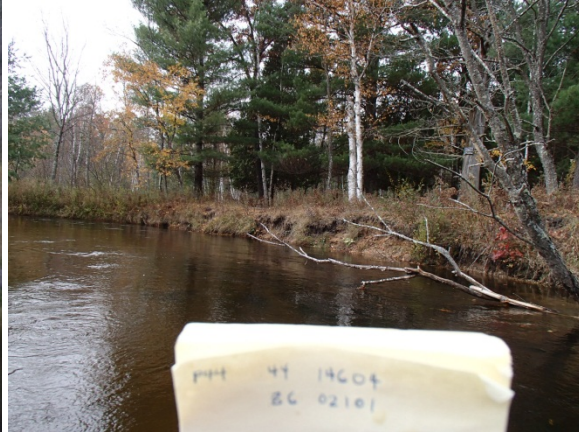
Site 40

River-right

Notes: substrate gravel and macrophytes, channel width 20', depth at toe 1.5'

View downstream (2011)

View downstream (2014)

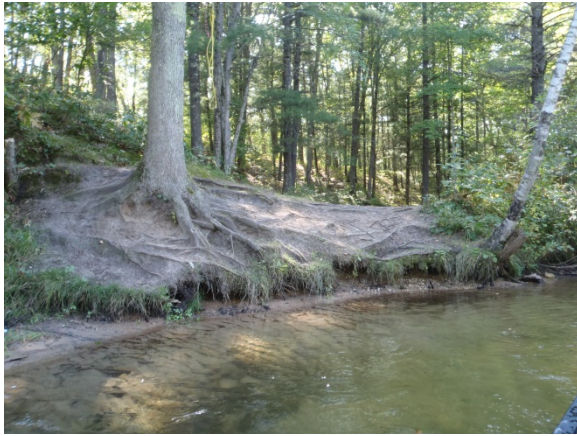
View downstream and across (2011)

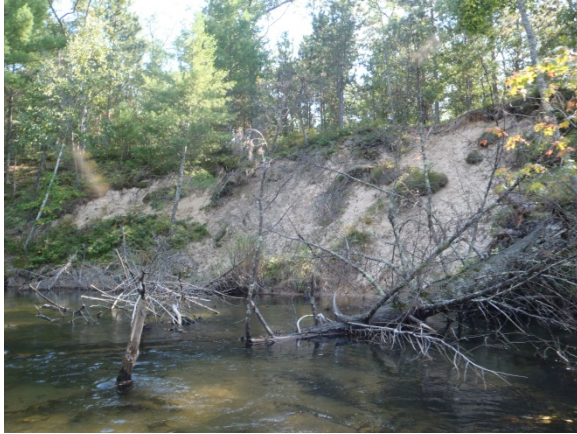
View upstream (2011)

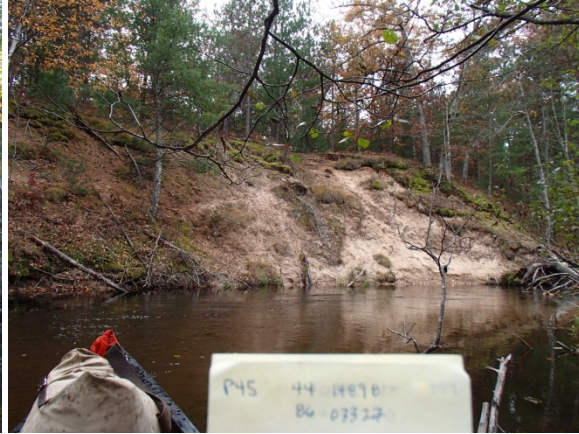
View downstream (2014)

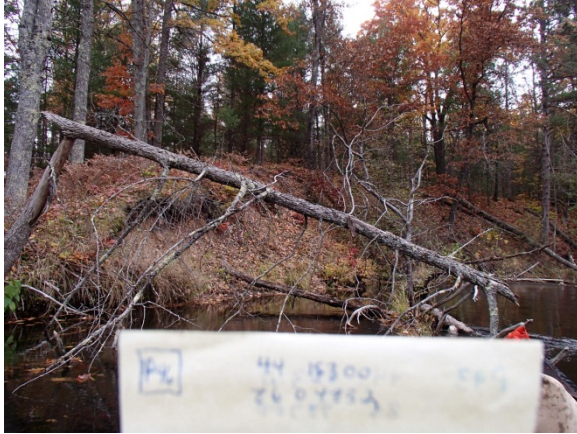
View downstream and across (2014)

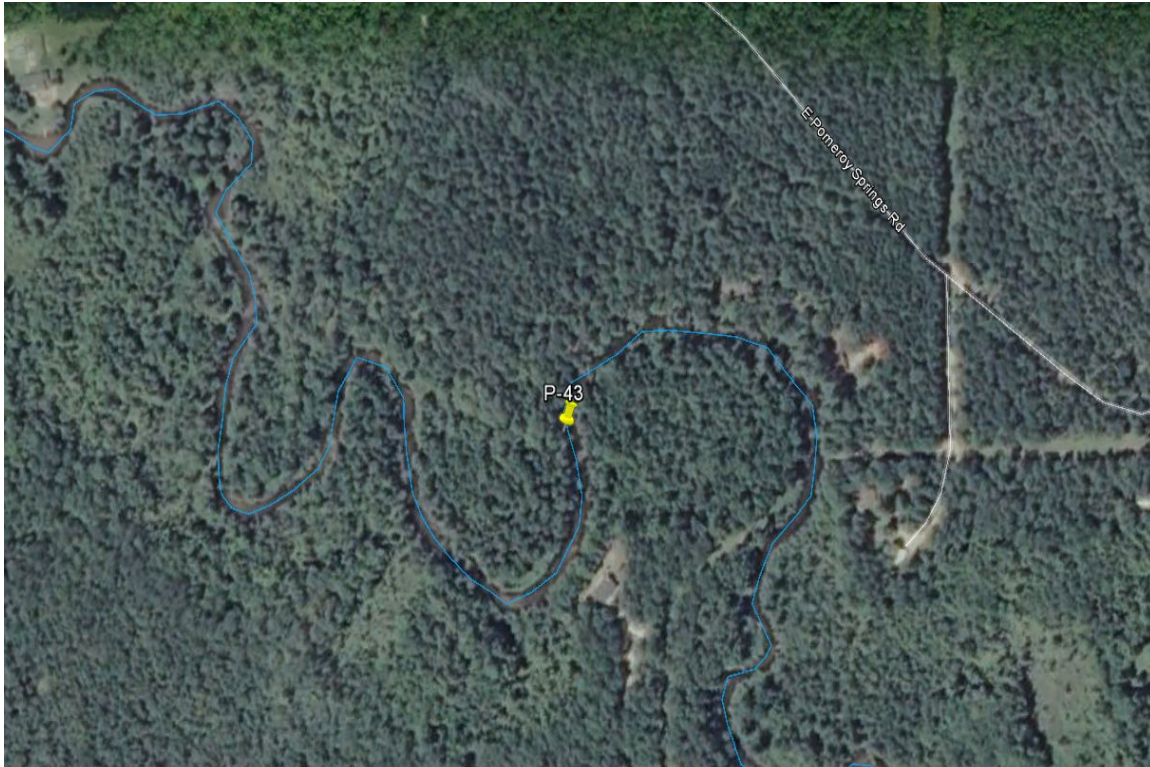
Site 44

Aspect: S

Slope: 1:1

Length: 15'

Height: 8'

Severity: Moderate

Notes: substrate sand/large wood/small gravel, depth at toe 3', minimal movement of wood in frame

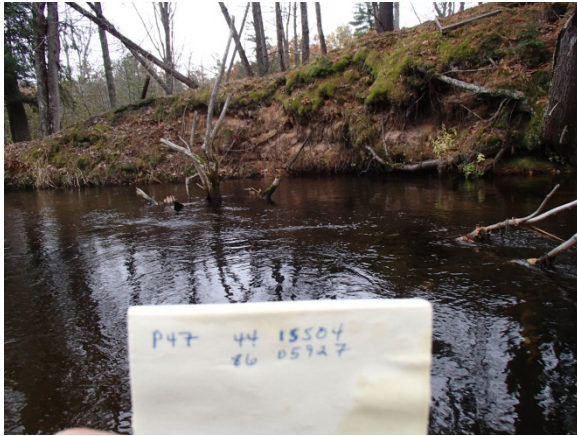
View upstream and across (2011)

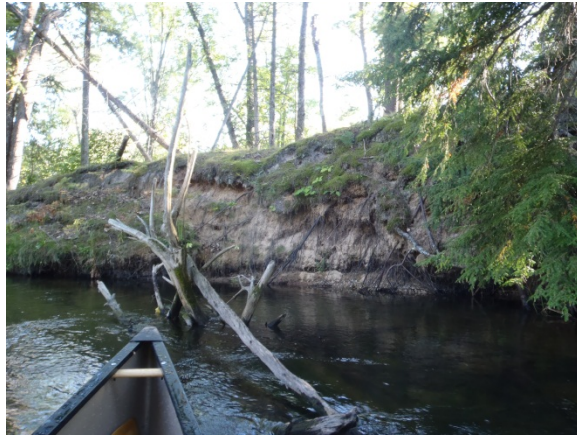
View upstream and across (2014)

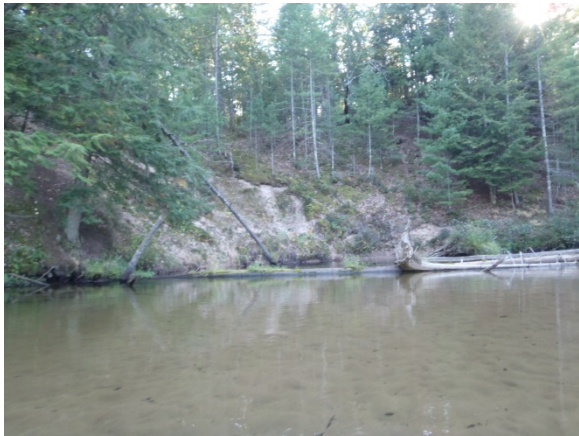
View looking downstream (2011)

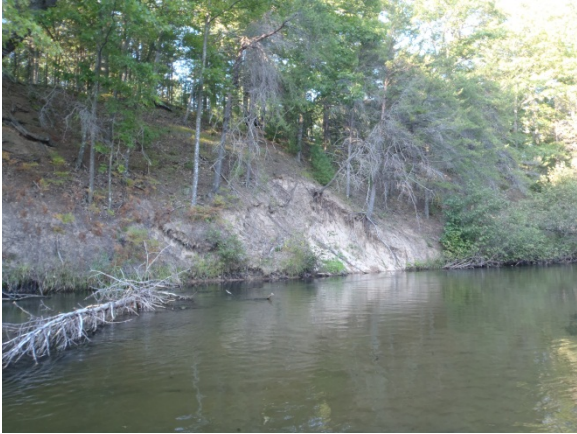
View downstream (2011)

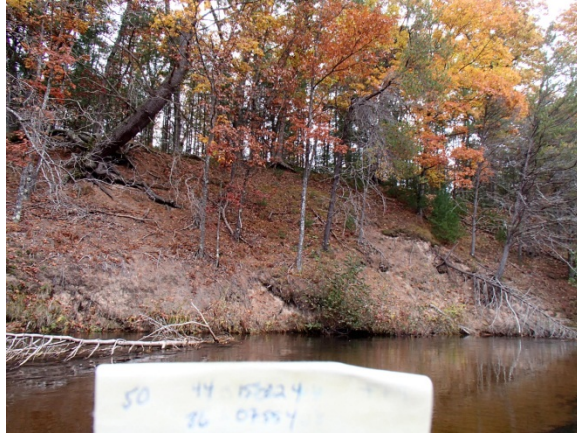
View downstream (2014)

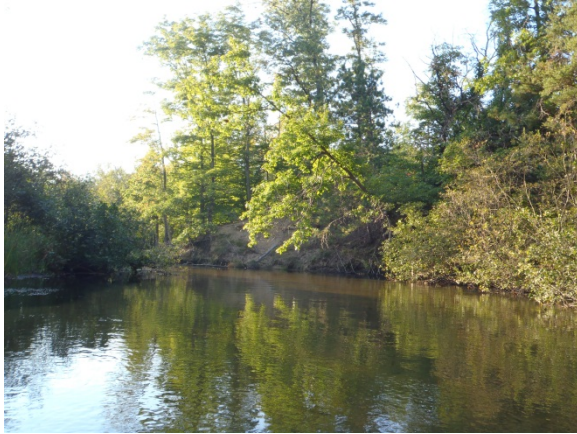
View downstream, approach to site (2011)

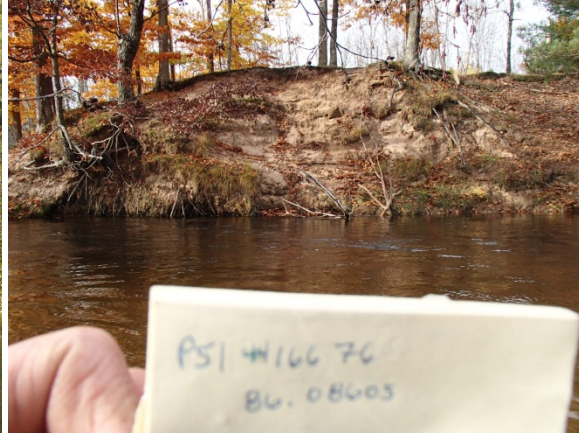
View across (2014)

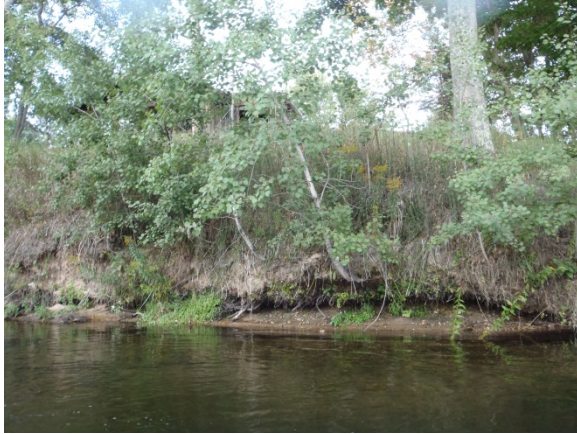
View across (2011)

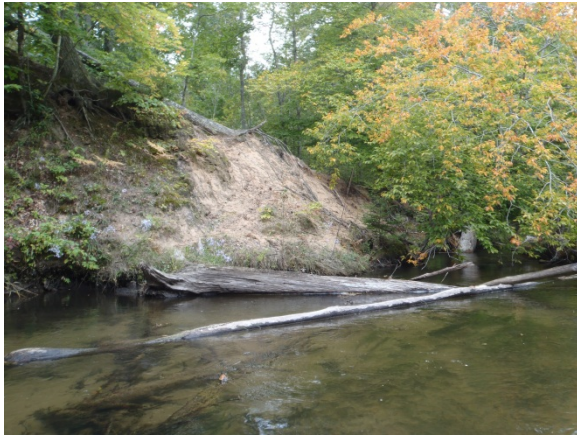
View across (2011)

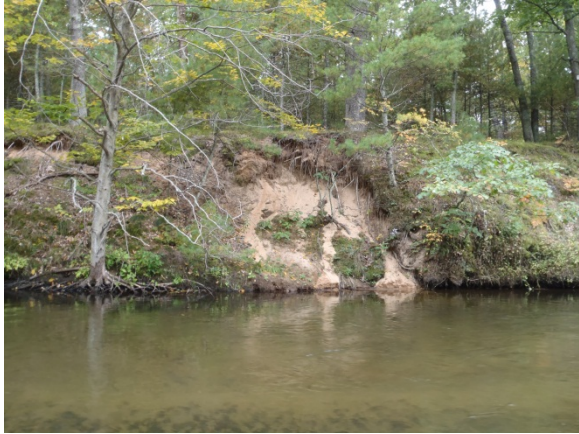
View across (2011)

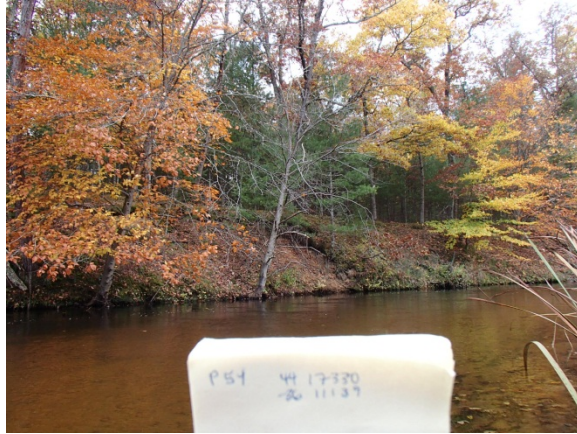
View across and upstream (2014)

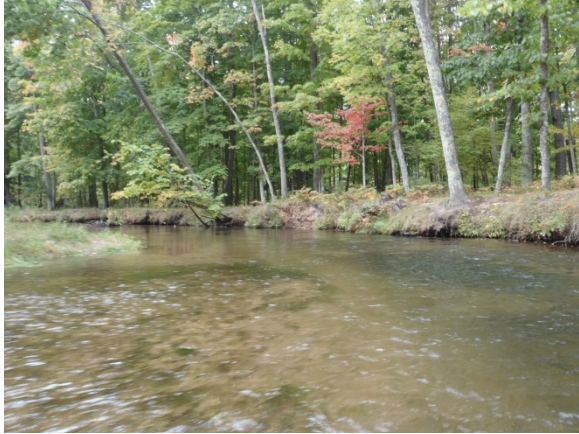
View downstream and across (2011)

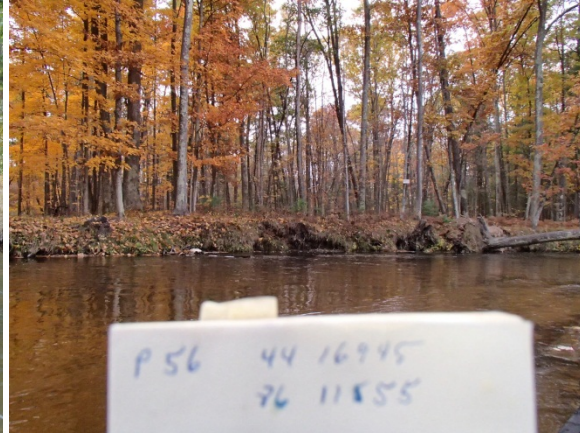
View upstream and across-note maple snag (2014)

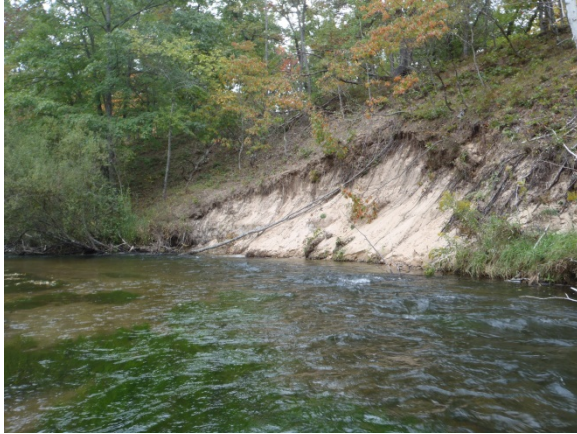
Notes: notable change in dimensions between 2011 and 2014, substrate gravel/sand, depth at toe 3'

View downstream (2011)

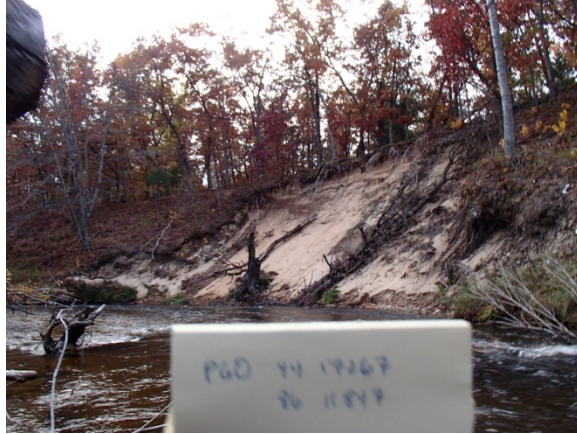
View downstream (2014)

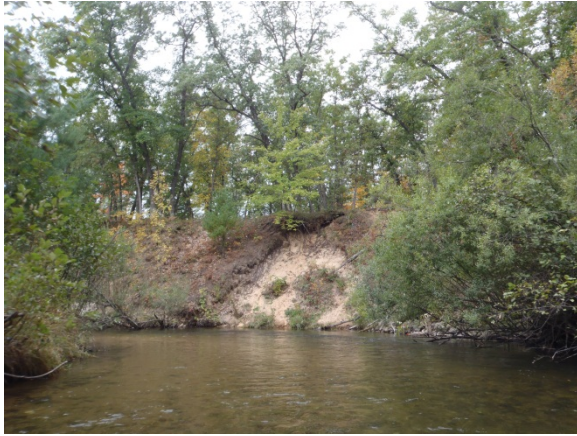
View of midsection of site (2011)

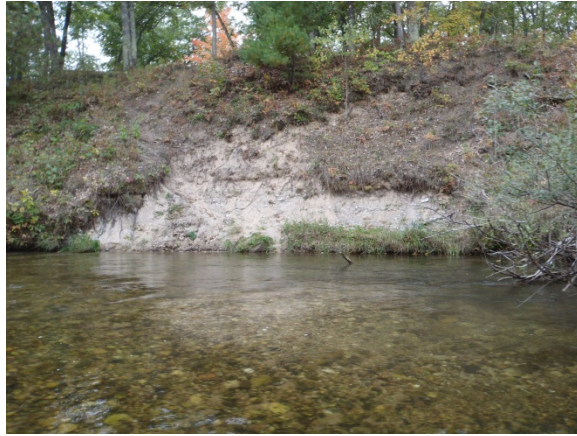
View of downstream end of site (2011)

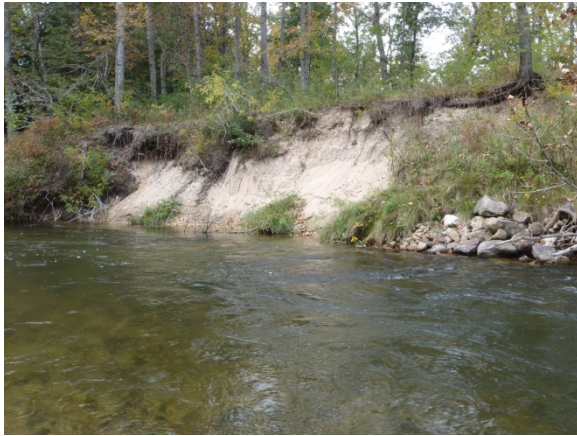
View downstream (2011)

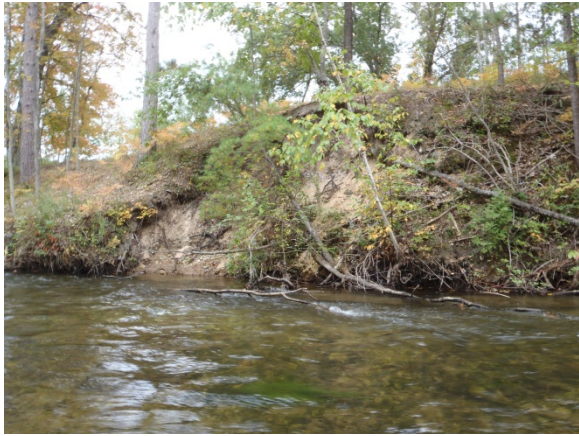
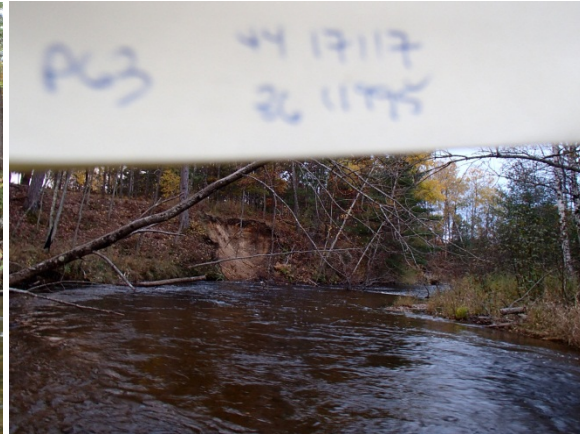
Site 56

Severity: Severe

Notes: clay ledge at toe, part of previously restored bank, substrate sand/small gravel/large wood, depth at toe 2'

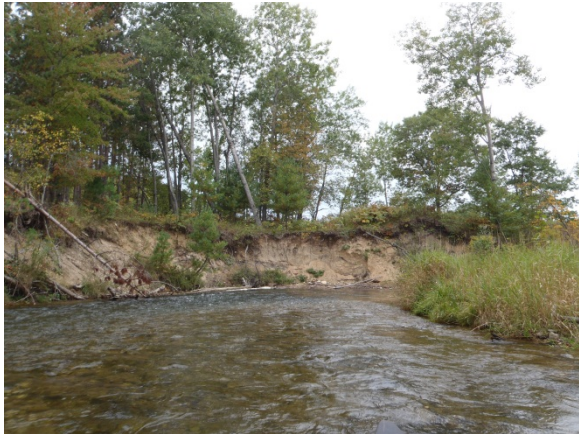
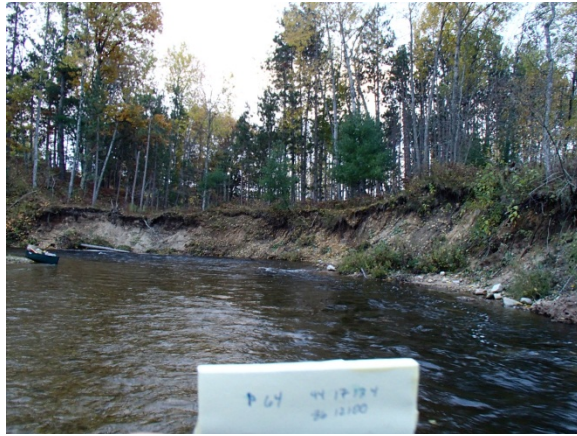
Site 57

Severity: Severe

Notes: clay ledge at toe, severity increased in intervening years

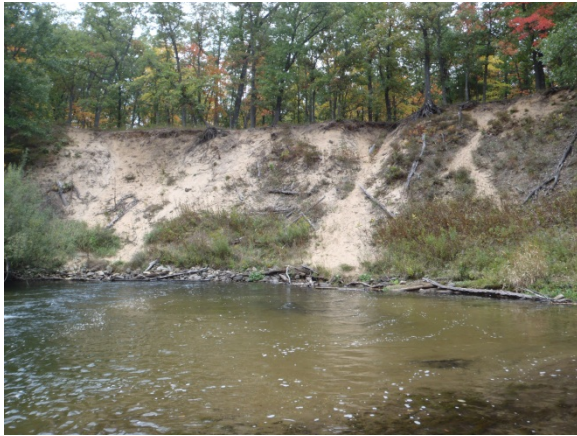
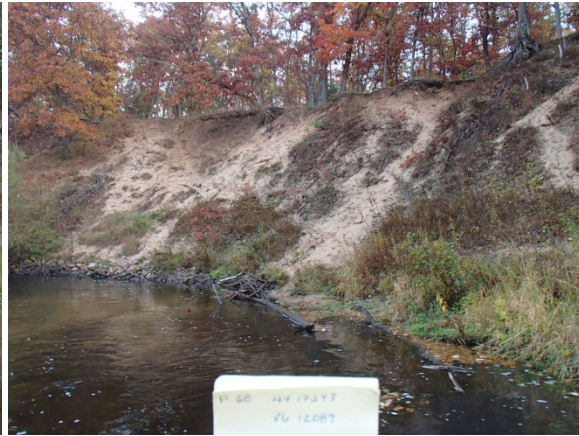
Site 58

Severity: Moderate

Notes: toe stable, prior work done, spring at toe, depth at toe 3', substrate sand/wood

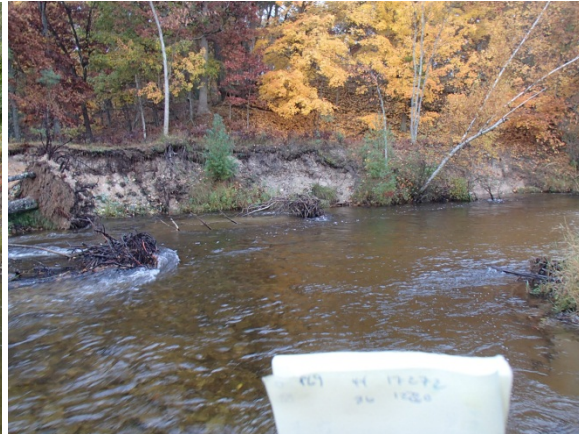
Site 59

Severity: Severe

Notes: angler access, continuation of prior site, clay exposed in bank, back eddies caused by debris jam, depth at toe 3'

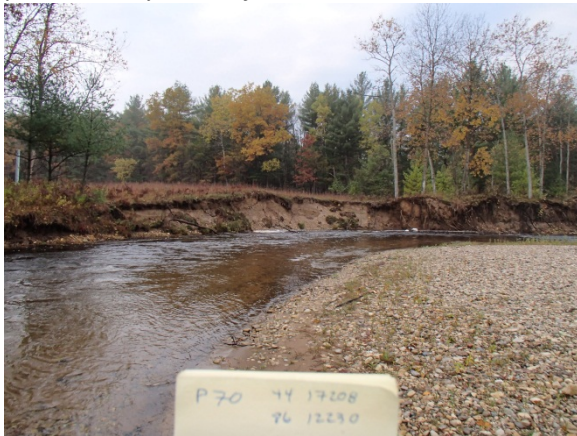
Site 60

Severity: Severe

Notes: depth at toe 2', substrate coarse gravel, rapid back eddy, large amount of gravel in bank, partly protected by debris jam

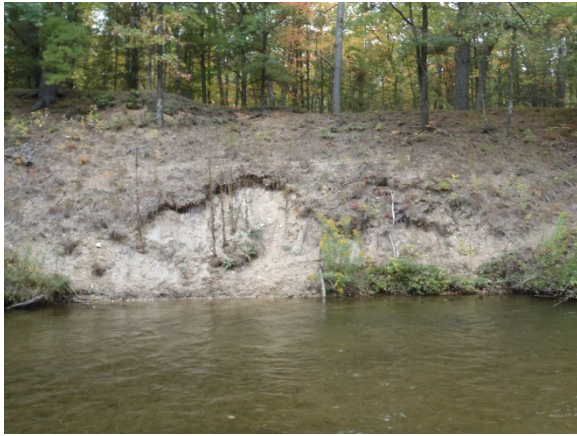
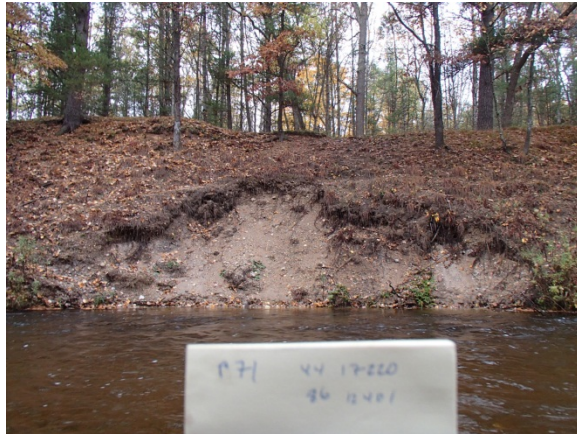
Site 61

Severity: Moderate

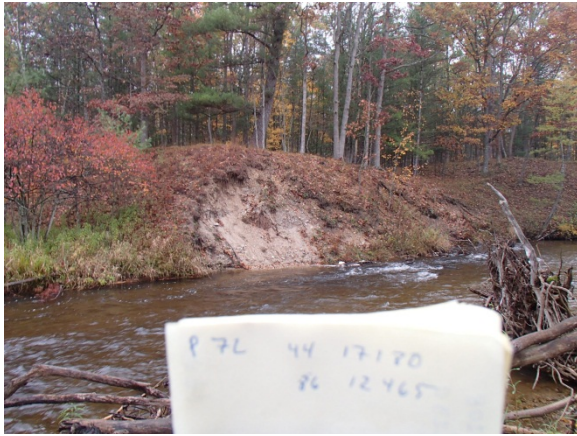
Site 62

Severity: Moderate

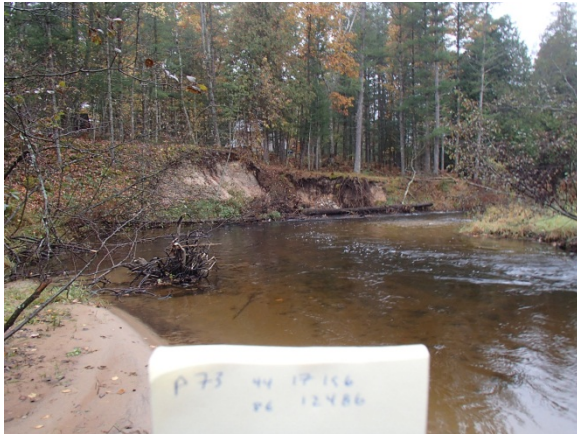
Site 63

Severity: Severe
