CONSERVATION RESOURCE ALLIANCE

Little Manistee River Eroding Stream Bank Assessment

Carrieville (Kings Highway) Bridge to Old Stronach Rd. Bridge

12/31/2014

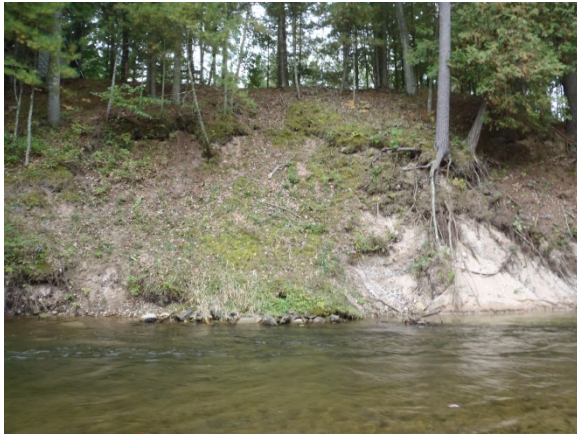
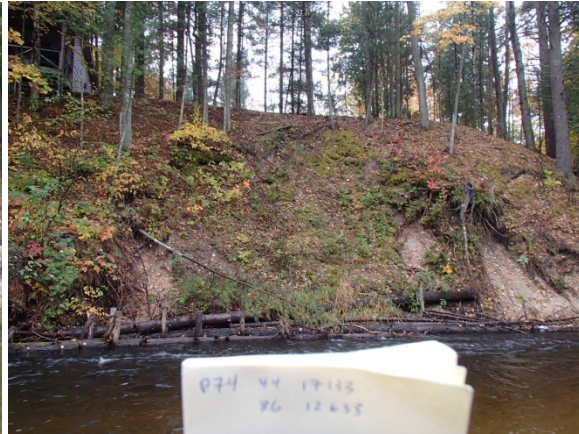
Site 64

Notes: substrate gravel/sand, depth at toe 3', back-eddy causing toe erosion, landowner dropped trees in 2011 frame and placed at toe for protection

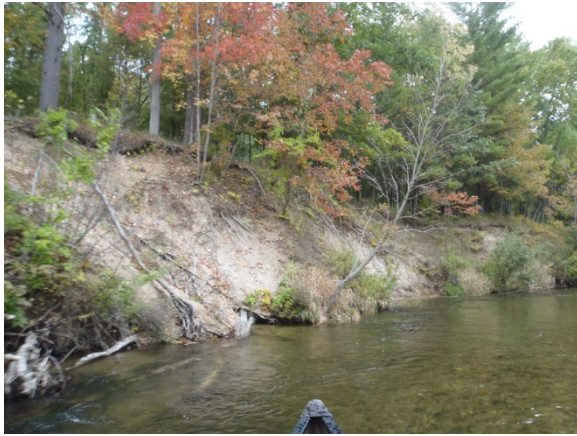
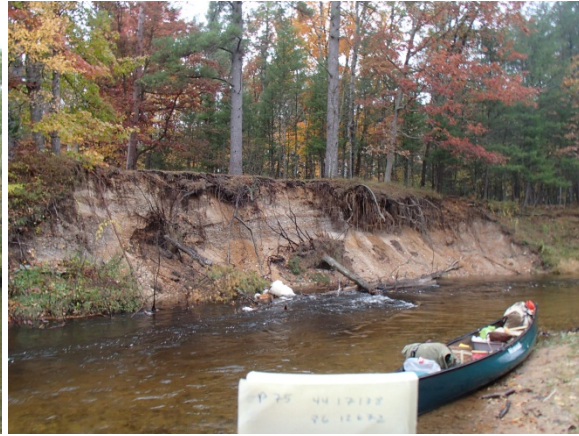
Site 65

Notes: depth at toe 3', substrate gravel/sand, erosion resulting from boiling and eddying from current deflecting off relic structure into toe

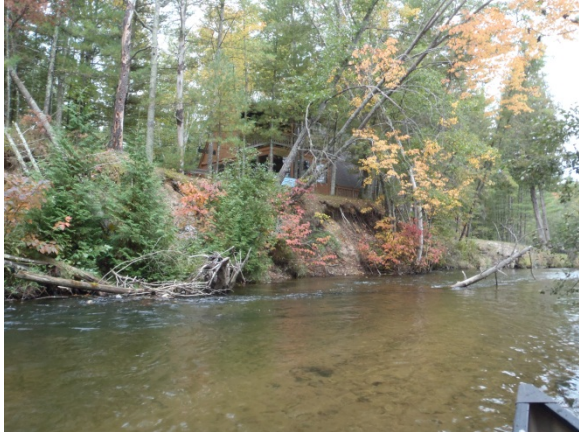
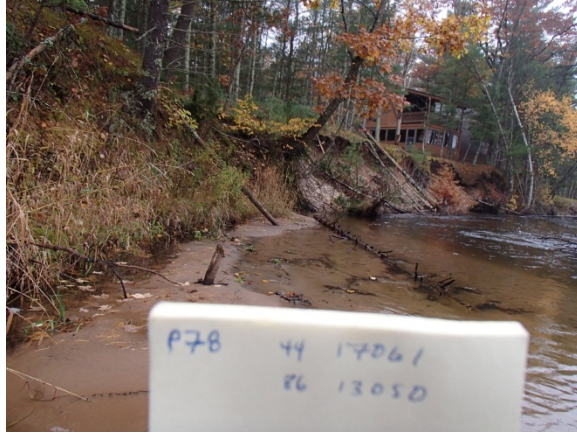
Site 67

Notes: substantial change in severity in intervening years

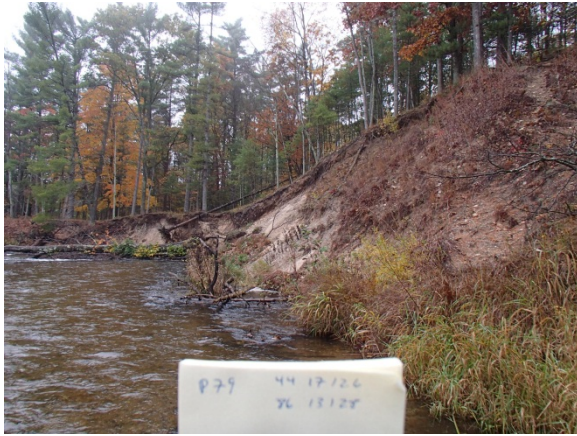
Site 68

Notes: new as of 2014 survey

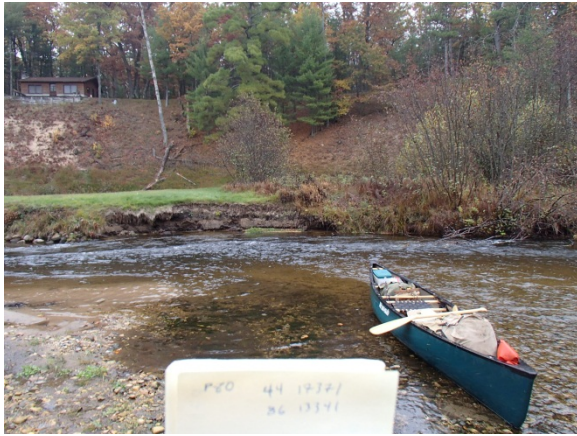
Site 69

Notes: a pond is located on the up-country side of the bank

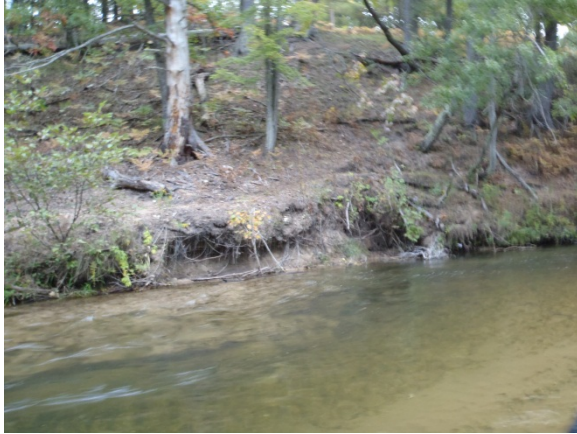
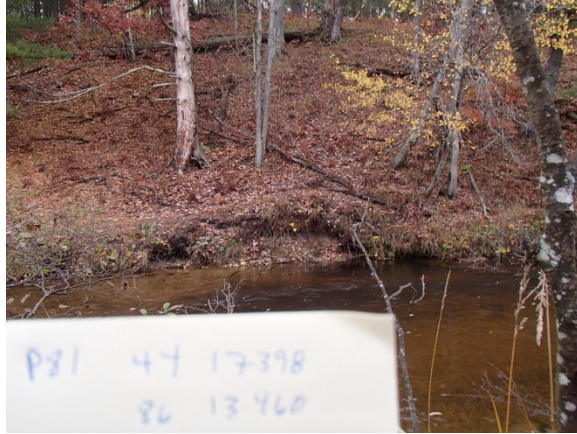
Site 70

Notes: angler path at top, substrate gravel/clay at toe

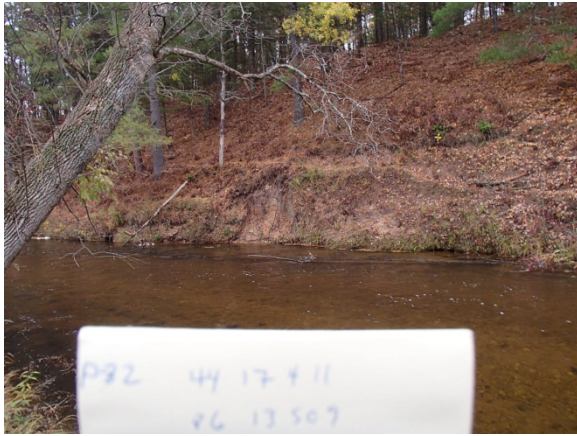
Site 71

Notes: angler path at top, substrate gravel/clay at toe

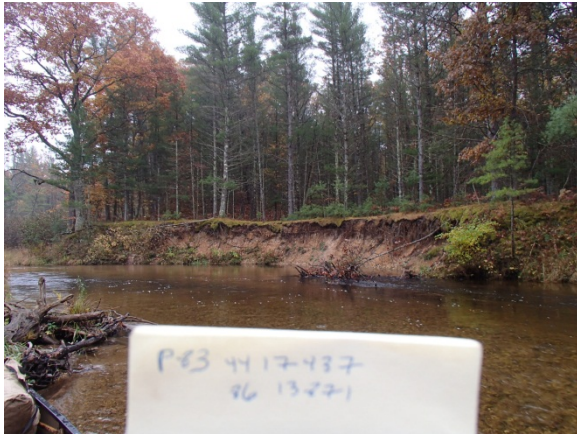
Site 72

Severity: Severe

River-left

Notes: new as of 2014 survey

View upstream and across (2014)

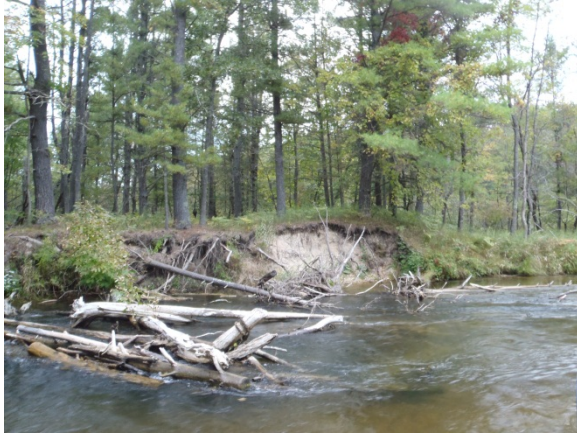
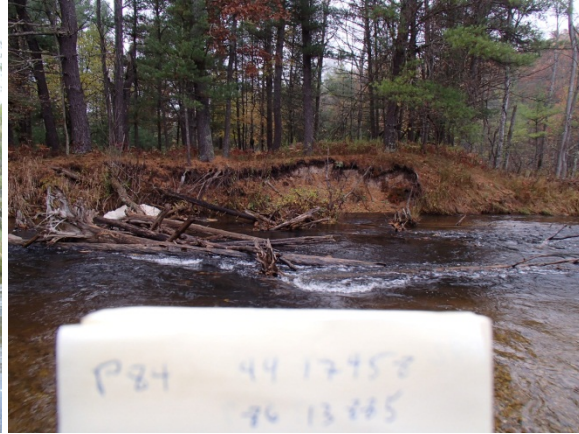
Site 73

Severity: Moderate

Notes: substrate gravel/sand/wood, depth at toe 3'

View across (2011)

View across (2014)

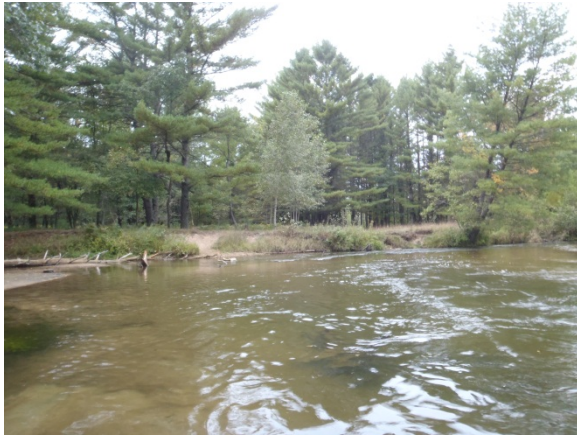
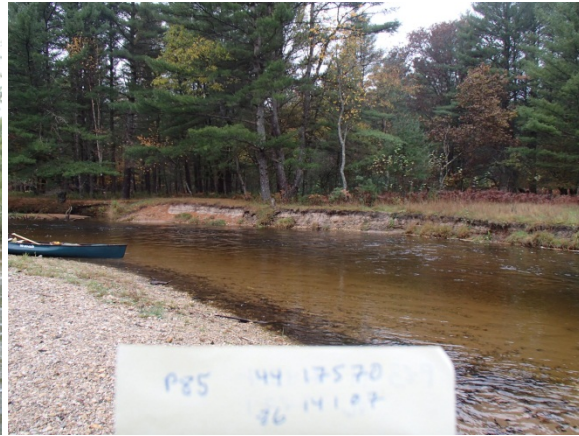
Site 74

Slope: 2:1 (2011), 1:1 (2014)

Severity: Minor (2011), Moderate (2014)

Notes: angler campsite and access, depth at toe 2', substrate gravel/cobble

View downstream (2011)

View upstream (2014)

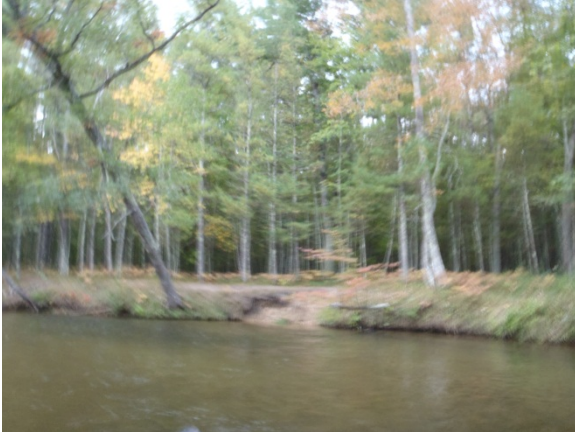
Site 75

Severity: Moderate

Notes: depth at toe 2', substrate gravel, downstream of tributary confluence, angler access trail adjacent

View upstream and across (2011)

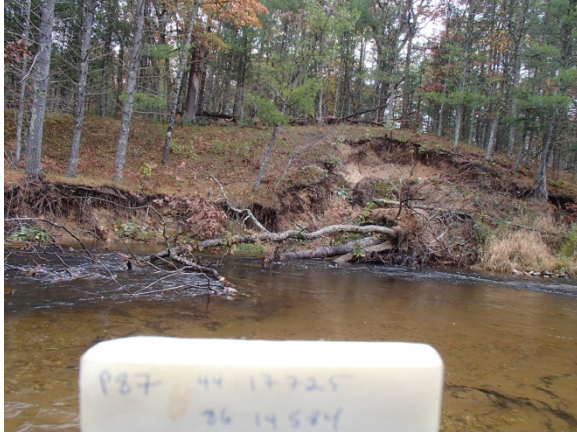
Site 76

Severity: Severe

Notes: stabilization efforts in past (toe-stone), calving of bank with tree slumping

View across (2014)

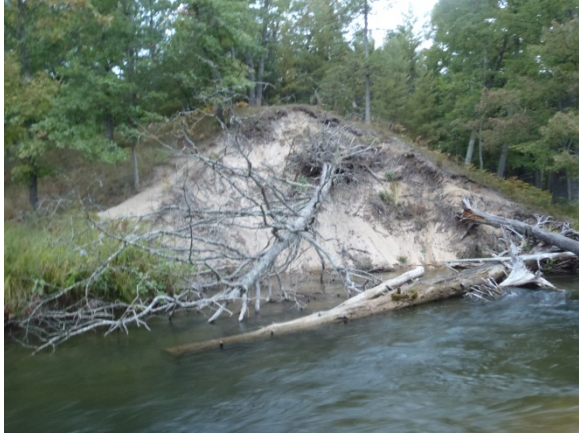
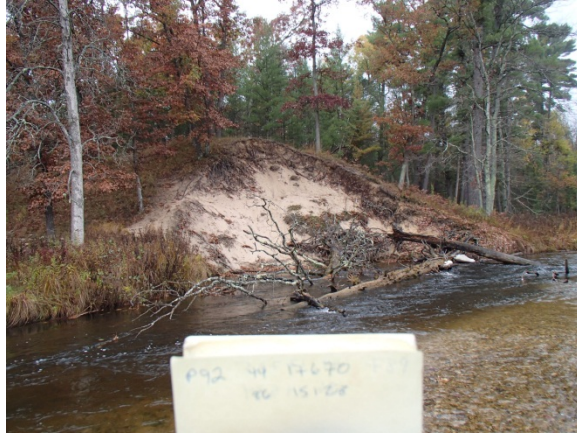
Site 77

Severity: Moderate

Notes: substrate gravel/sand, water depth 3'

View across (2011)

View across (2014)

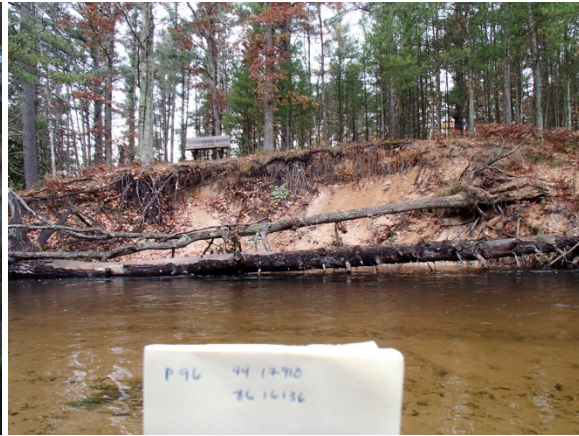
Site 78

Severity: Severe

Notes: "Clyde's" bench, substrate small gravel, depth at toe 3.5'

View downstream (2011)

View across (2014)

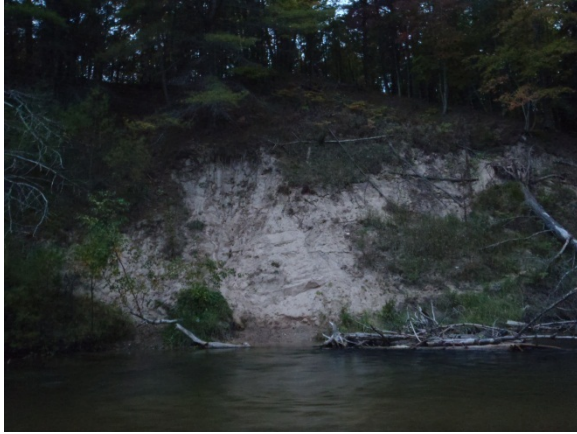
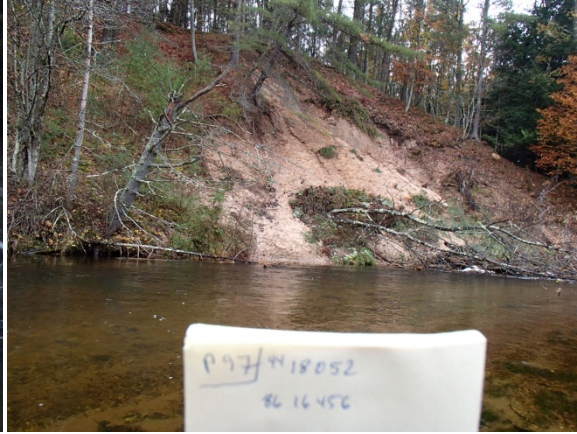
Site 79

Severity: Severe

Notes: last site upstream of 6 Mile Bridge

View straight on (2011)

View downstream and across (2014)

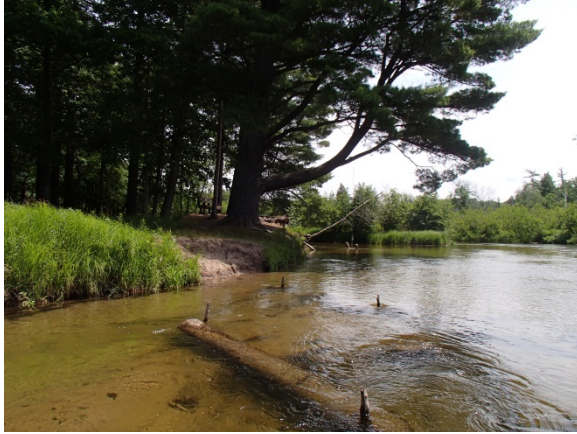
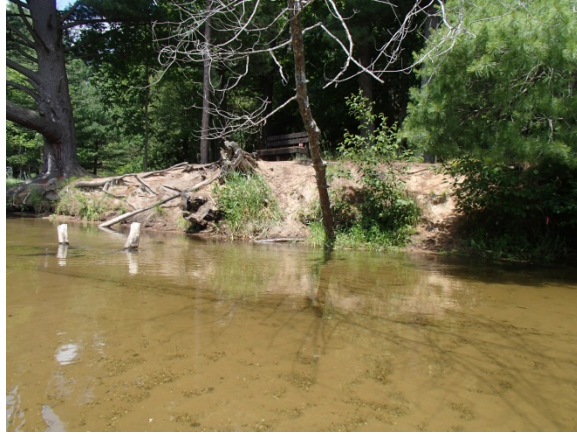
Site 80

Severity: Moderate

Notes: recreational access, depth at toe 1.5', substrate sand, relic structure present

View upstream, erosion extends around corner (2013)

View of mid-section (2013)

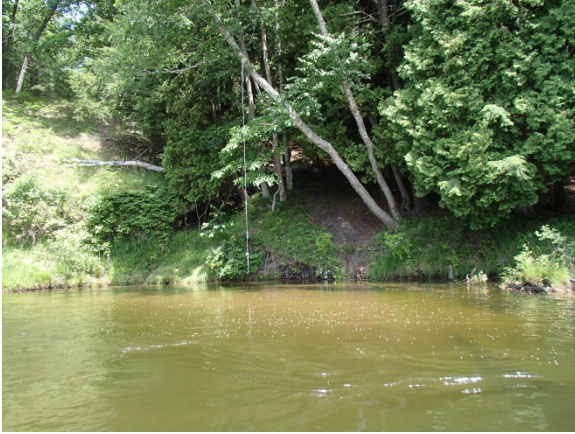
Site 81

Severity: Moderate

Notes: depth at toe 1.75', substrate clay/sand, swimming hole (12' deep) adjacent

View across (2013)

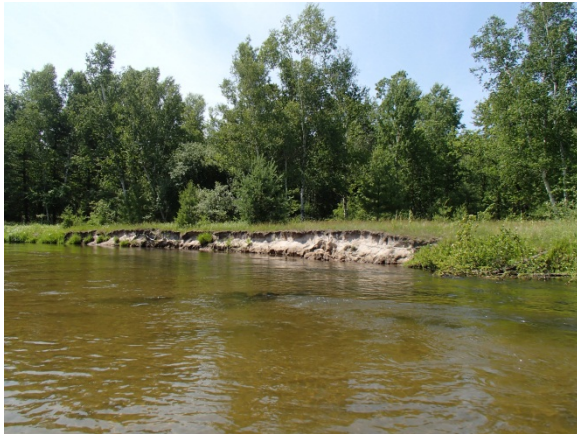
Site 82

Severity: Severe

Notes: depth at toe 3.5', substrate gravel/sand

View upstream and across (2013)
